## Propeller Shaft Seal - 25, 45/50 (4 Stroke) & 30/40, 40/50, 55/60 (2 Stroke)

### Models Affected

1998 Mariner/Mercury

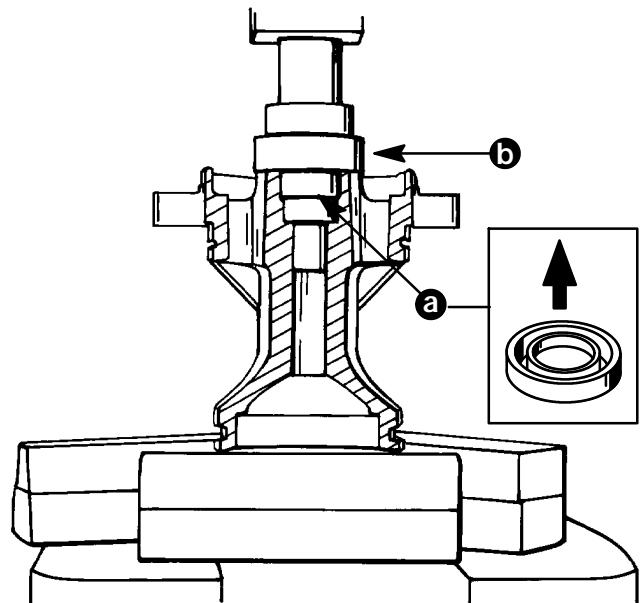
The outer propeller shaft seal in the bearing carrier on the models listed may cause water to enter the gear housing. Replacement of the seal is required for outboards within the serial numbers listed that have not been reworked at the factory. The seal that requires replacement has a carbon steel compression spring and is replaced with a seal using a stainless steel spring. Outboards reworked at the factory have a green dot on the upper rear of the gear housing above the anti-ventilation plate and a green dot on the outside of the shipping carton next to the serial number for identification.

a - Outer Seal

b - Mandrel 91-817007

Replace the outer propeller shaft seal on outboards within the serial numbers listed that have not been reworked at the factory. It will be necessary to remove the bearing carrier from the gear housing. Remove and replace only the outer propeller shaft seal. The outer seal is installed with the seal lips facing out. Apply grease between the two seals for extra durability. Refer to the service manual for proper seal installation instructions. Paint the end of the propeller shaft white to identify the installation of the new seal.
