Top Cowl Unlatching – 1989 and 1990 Mariner/Mercury 135-200

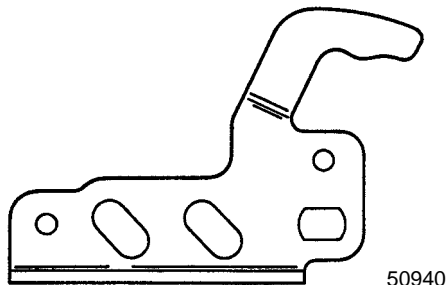
Previous Latch P/N 813076--1

Figure 1. Front Cowl Latch

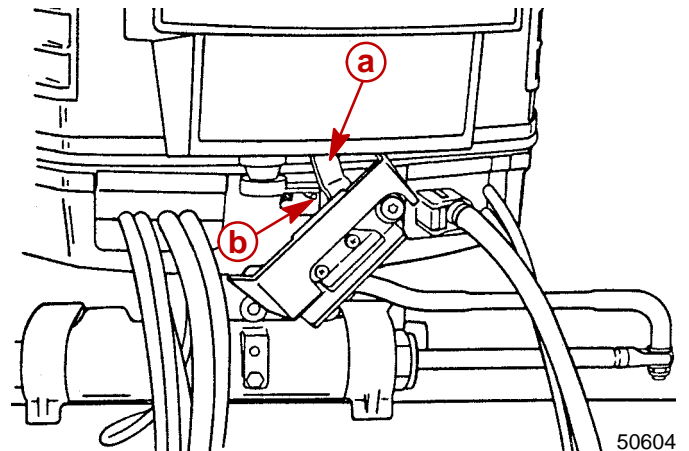
Figure 2. Front Latch Assembly

To prevent top cowl from unlatching when outboard is operated on rough water, it is necessary to install items listed. Earlier models require redesigned front cowl latch, longer safety latch pin and washer on both rear latch hooks. Later models require washer on both rear latch hooks. Models S/N 0C273935 and above have all items installed.

Previous P/N 17-813930 - 7/8 in. (22mm) long

Qty. 1 P/N 813076--2 Front cowl latch

Qty. 1 P/N 17-815296 Pin – safety latch

New P/N 17-815296 - 1 in. (25mm) long
