service bulletin

No. 91-28

Power Trim Relay Inspection – 1992 50 and 60

1992 50 and 60 Power Trim Models

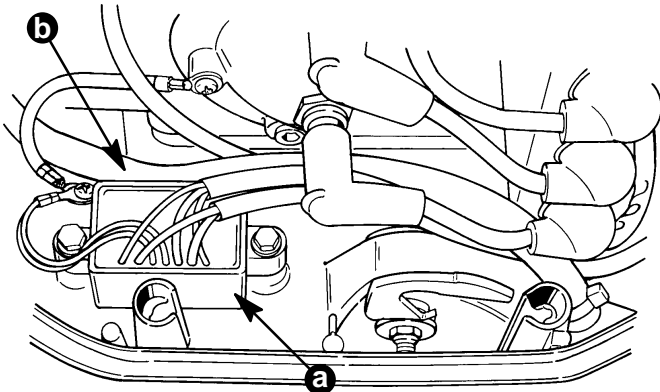
51522

Replace any power trim relay that has a production date code 1071 thru 1771 printed on the case. The power trim relay is mounted in the rear port side of the lower cowl.

a - Power Trim Relay
b - Relay Production Date Code
