Pre-loaded Reeds - 6 thru 15

Mercury/Mariner

1994 6 thru 15

S/N 0G157511 thru 0G157993

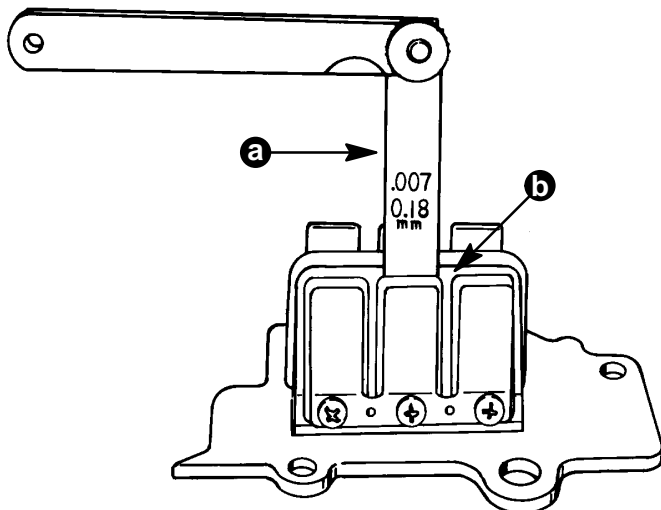
53280

Outboards listed have experienced a condition which required a significant richening of the mixture screw in order to accelerate off idle. The cause of this condition is bent reeds which were assembled to the reed block in the "pre-loaded" direction. This condition could result in poor running qualities or early breaking/chipping of reeds.

a - Feeler Gauge
b - Reed

1. Install new reeds, p/n 34-825141.
2. Secure reeds and stops to reed block with six screws. Torque screws to 20 lb. in. (2.3N-m).
3. After installation, check reeds for preload and stand open conditions. Stand open should not exceed 0.007 in.(0.178mm).

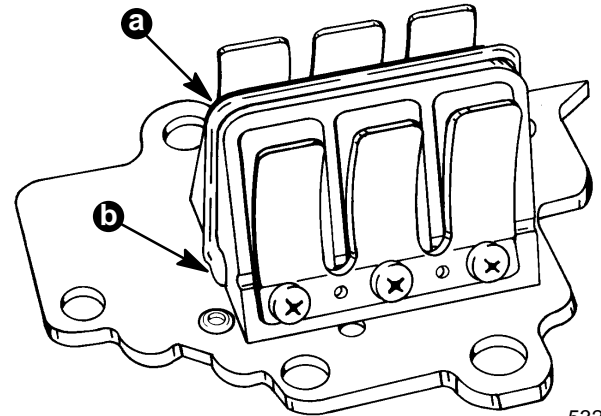
53202

a - Rubber Seal
b - Apply Sealant (Each Side)

4. Replace seal, p/n 26-42137, and apply RTV Sealant (92-91600--1) at each location where seal passes through manifold
5. Reassemble engine and perform carburetor adjustments as outlined in service manual.
