## Official Notification Federal Boat Safety Act – Steering Arm 3.0 Litre

MERCURY/MARINER  
225/250 HP, 3.0 LITRE (Carb/EFI) XL, CXL, XXL, & CXXL  
200/225 HP, 3.0 LITRE (Optimax) XL, CXL, XXL, & CXXL  
S/N 0G644802 Thru 0G870075

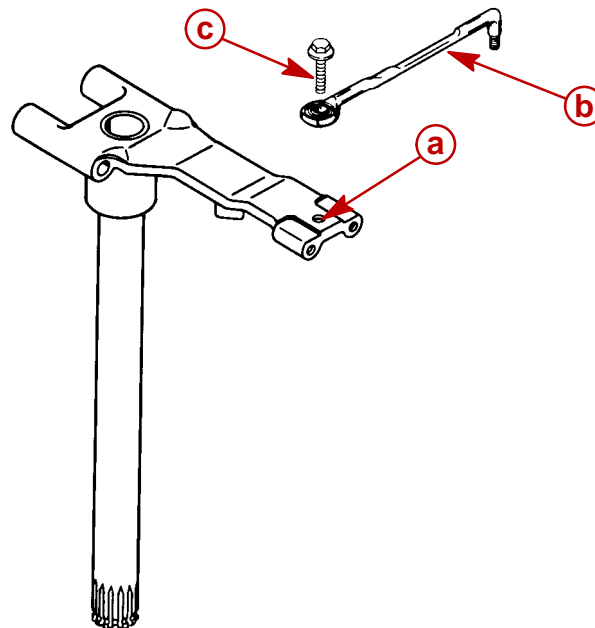
The steering arm attaching bolt hole, may be incorrectly chamfered. Under extreme steering torque conditions, this may cause extra strain on the link rod attaching bolt, which could result in bolt failure (steering disconnect). Breakage of the attaching bolt has not been reported on any standard production product, but as a precautionary measure, the standard attaching bolt should be replaced with a stronger, more durable bolt (See Parts Required).

- a - Attaching bolt hole
- b - Steering link rod
- c - Attaching bolt

Affected engines in the above serial number range should have the link rod to steering arm attaching bolt replaced with the stronger more durable bolt. Engines using OEM/after market steering systems may require various length bolts. Choose the correct bolt length from the following chart. Since the stronger more durable bolts are not offered with shoulders, engines using Teleflex clevis Kit P/N SA27314P with shoulder bolt, must replace the clevis with Quicksilver clevis kit P/N 70599A5, and also use the more durable bolt from the following chart.

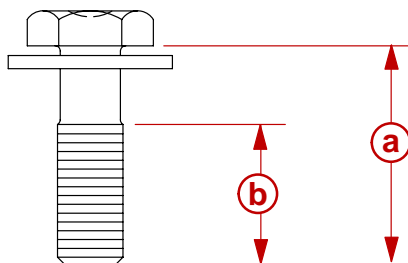
SCREW LENGTH "A"	THREAD LENGTH "B"	PART NUMBER
1.250 (31.75 mm)	.800 (20.3 mm)	10 - 849838
1.380 (34.92 mm)	1.000 (25.4 mm)	10 - 875273 - 138
1.500 (38.10 mm)	1.000 (25.4 mm)	10 - 875273 - 150
1.625 (41.28 mm)	1.000 (25.4 mm)	10 - 875273 - 162
