- A. Thunderbolt Ignition - Spark When Switch "On" or "Off"
- B. Battery Lead and External Harness Installation - Merc 650
- C. Water Pump Impeller Installation
- D. Emergency Cowl Removal - 1974 Merc 110-75
- E. Bottom Cowl Drain - 1974 Merc 110-75

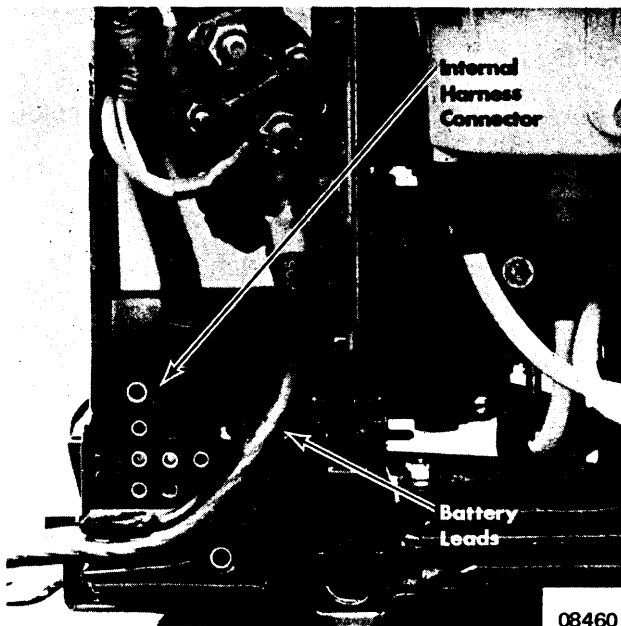
Figure 1. Internal Harness Connector and Battery Leads in Position

Mechanics and boat riggers are cautioned to properly install external harness and battery leads on Merc 650 Outboards as shown in Figures 1 and 2. Install a sta-strap around the harness, battery leads and control cables as shown in Figure 3.

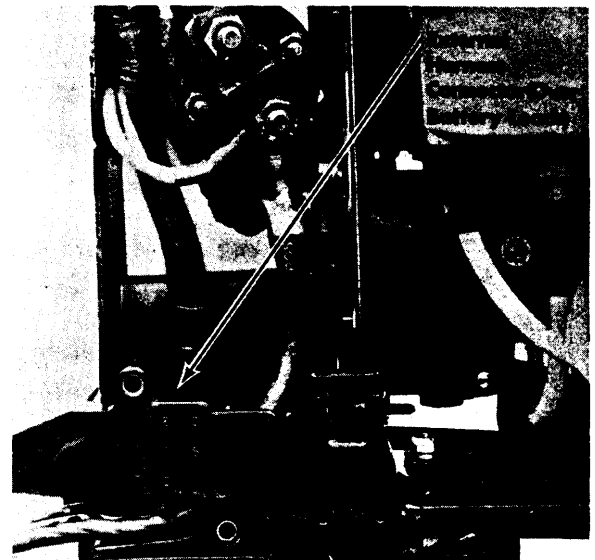
Figure 2. External Harness Connector over Battery Leads

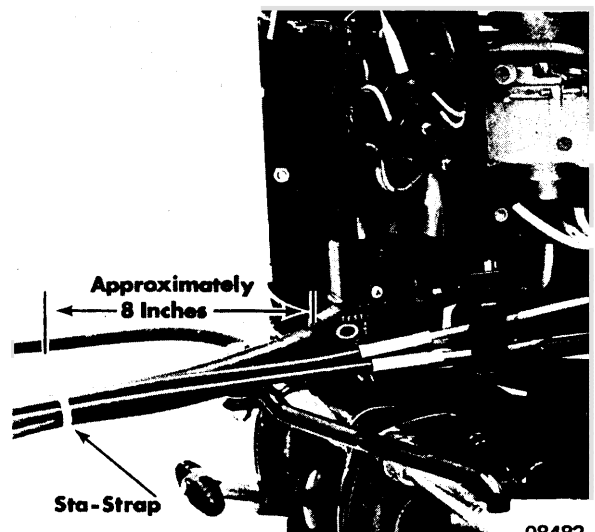
Figure 3. Sta-Strap Installed around Harness, Battery Leads and Cables

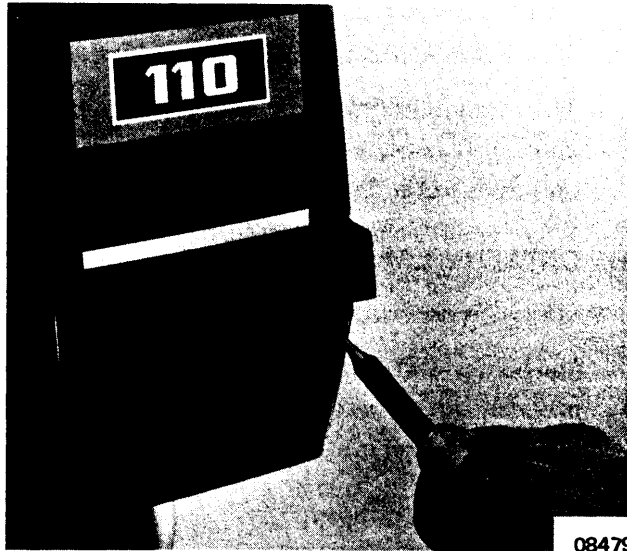
If the top cowl latch fails to function on a 1974 Merc 110-75, proceed as follows:

Figure 4. Inserting Rod in Hole

1. Insert a 11/64" (4.4mm) maximum diameter rod through the hole in the right rear of the bottom cowl, as shown in Figure 4.
2. Push the rod against the cowl release lever and remove the cowl by lifting off (up and forward).

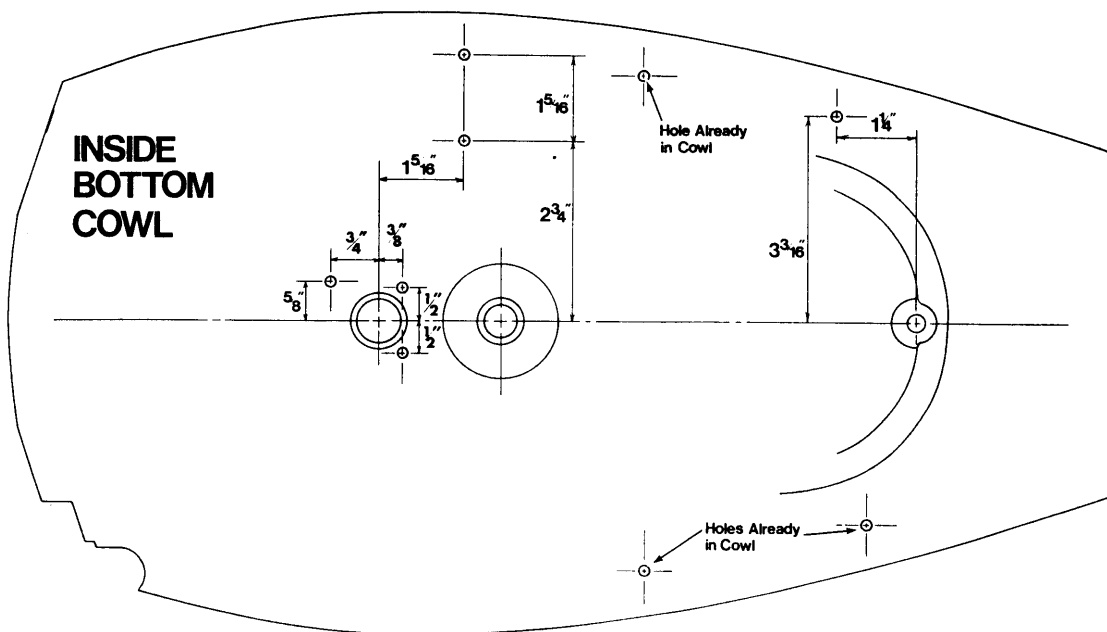
Figure 5. Six 3/16" Diameter Holes in 1974 Merc 110-75 Models

Model 1974 Merc 110-75 Outboards require 6 additional drain holes in the bottom cowl assembly. Drill the six 3/16" (4.8mm) diameter holes as shown in Figure 5.
