NUMBER: 84-9

FUEL PUMP IMPROVEMENT MARINER 20 (U.S. BUILT) MERC 18XD & 25XD

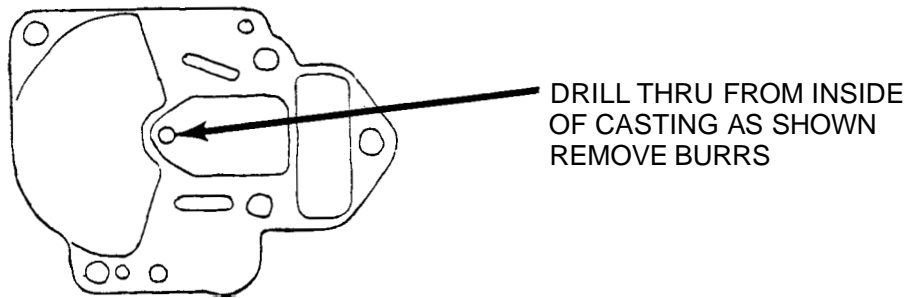
THIS VENTS THE BACK OF A PULSE CHAMBER

1. Disassemble fuel pump plate from carburetor, discard gasket and black diaphragm.
2. Drill $1/8"$ (.125) hole thru fuel pump cover plate as shown.
