A. Water Hose Rerouting - Mariner/Mercury 50 and 60 Models

A. WATER HOSE REROUTING - MARINER/MERCURY 50 AND 60 MODELS

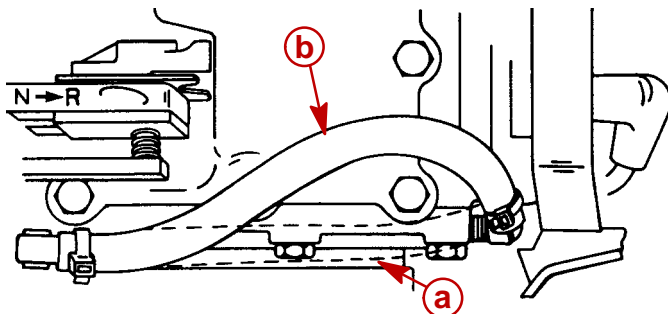
Figure 1. Side View

The water bypass hose (located on lower port side of powerhead) is susceptible of chaffing because of interference between a fastener and the side cowl. Although this is not a serious problem we want it corrected before it causes any inconvenience to the owner or operator.

- a - Location of Previous Hose
- b - New Hose

The correction is to replace the 8-1/4 inch (216mm) hose with a 9 inch (229mm) hose and to reposition the rear elbow at 20°. Instructional illustrations are shown below. One hose P/N 32-75680-56 [cut to 9 inches (229mm)] and two sta-straps P/N 54-90077 are required. Labor allowance is 0.5 hour.

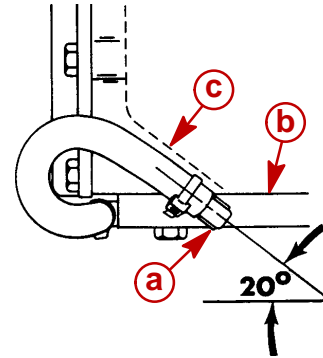
Figure 2. Rear View

- a - Rear Elbow
- b - Exhaust Extension Plate
- c - Rear Cowl Support Bracket
