OptiMax Air Compressor Hub Runout

Models Affected:

Models Covered	Serial Number
75 – 115 HP; 1.5 Liter OptiMax	SN 1B445150 through 1B446575
135 – 200 HP; 2.5 Liter OptiMax	SN 1B445150 through 1B447802
200 – 250 HP; 3.0 Liter and Pro-XS OptiMax	SN 1B445150 through 1B447437

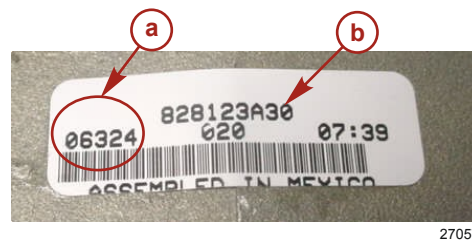
On the OptiMax engines, if excessive belt wear is present before the recommended service interval for the belt, inspect the air compressor for the Julian date code range of 06305 - 06341. This is the manufacturing date of the suspect compressors. On 2.5L and 3.0L engines this date code is easily seen without removal of the compressor. If the Julian date is not within this date code range, the compressor is not affected by this service bulletin.

Julian date range of 06305 through 06341 is considered suspect

If the compressor is within the Julian date code range, refer to the following inspection method.

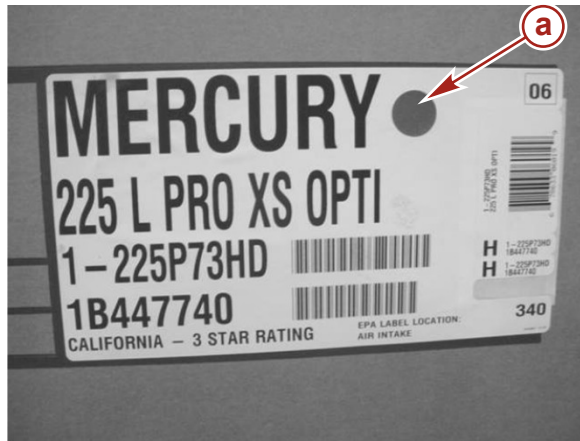
27067

If the engine is still in the shipping container: If the serial number mat has a blue dot as shown, this indicates the engine has been inspected at Mercury Marine and no further action is required.

a - Blue dot

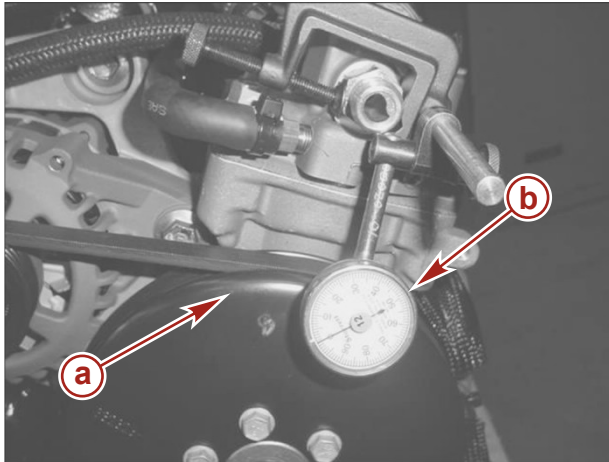
27071

Accept/reject criteria: Maximum total indicator reading (TIR) allowed is 0.5 mm (0.020 in.), measured at a point approximately 9.5 mm (3/8 inch) from the outer edge of the compressor pulley.

- Adjust the dial indicator on the secondary clamp arm. The indicator tip must be in contact with the pulley at a point approximately 9.5 mm (3/8 inch) from the outer rim of the pulley, where the radius turns down toward the belt.

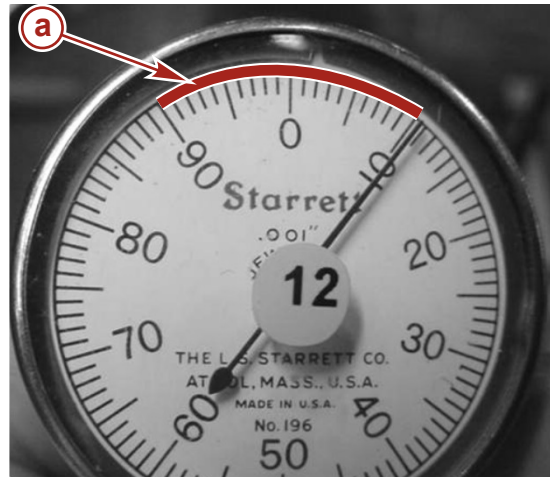
27072

a - Needle travel

IMPORTANT: Total indicator reading (TIR) allowed is 0.020 in. when pulley is rotated one full revolution

- **If Passed:** (TIR less than 0.020 in.) Go to Step 7.
 - **If Rejected:** If the above runout condition is above specification, the compressor unit complete will require replacement. Ensure the replacement compressor is not within the affected Julian date code range. Then, continue with Step 7.
7. Mark the inspected and passed engine with a blue paint mark on the compressor pulley shaft.
