Flo-Torq II Hub Kit (Thrust Washer Taper)

Models Affected

Description	Part Number
Evinrude, Johnson, OMC	835265Q02

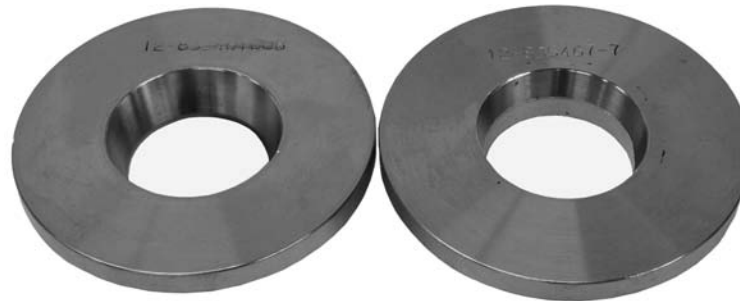
Mercury Marine offers a diverse line of propeller hardware and accessories. The above hub kits for installing Mercury/Quicksilver propellers may contain the wrong forward thrust washer P/N 12-835467 7. This thrust washer allows the propeller to be positioned too far aft on the prop shaft. When using this washer, the result may be ventilation or blow-out during acceleration because the exhaust gases may leak over the hub instead of through it.

NOTE: The two different thrust washers look very similar with the only difference being the depth in which the taper is machined. The taper on P/N 12-835467008 is almost all the way through the washer and the taper on P/N 12-835467 7 is about halfway through the washer.

P/N 12-835467008 with full taper on ID

P/N 12-835467 7 with half taper on ID

If the application is experiencing ventilation or blow-out of the propeller when using kit part number 835265Q02, the installer must visually check for the taper difference as shown in the graphic below. If the application shows a washer with a half taper bore, the thrust washer must be replaced with P/N 12-835467008.

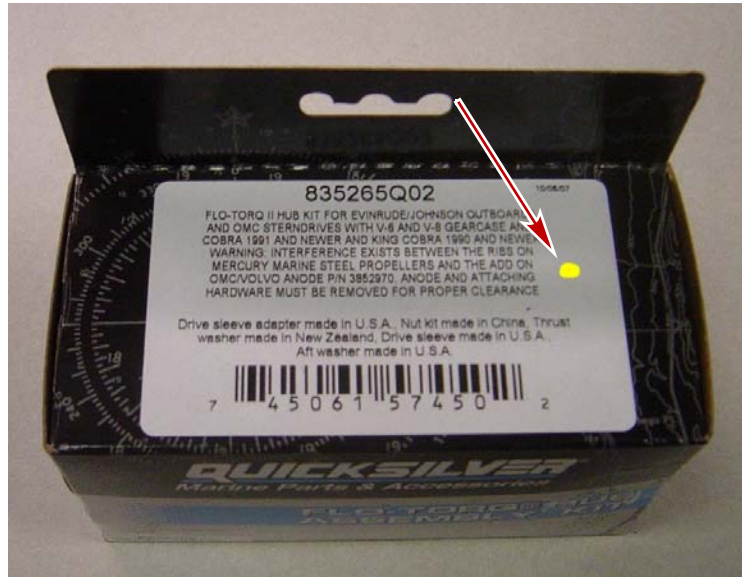
32887

Mercury Marine has corrected the affected Flo-Torq II hub kits in stock. The affected kits at Mercury Marine have been reworked to include the thrust washer P/N 12-835467008. The kit can be identified by a yellow dot on the part number label.

Date codes between June 29, 2006 and November 16, 2007 should be inspected for the yellow dot on the label. If the yellow dot is not on the label, inspect the kit for the correct washer. If the washer is incorrect, replace with the correct P/N 12-835467008.
