Fuel Hose Routing and Inspection

MERCURY/MARINER/TRACKER

2001 Model Year 135/150/175 HP Optimax

S/N OT178500 Thru OT364902

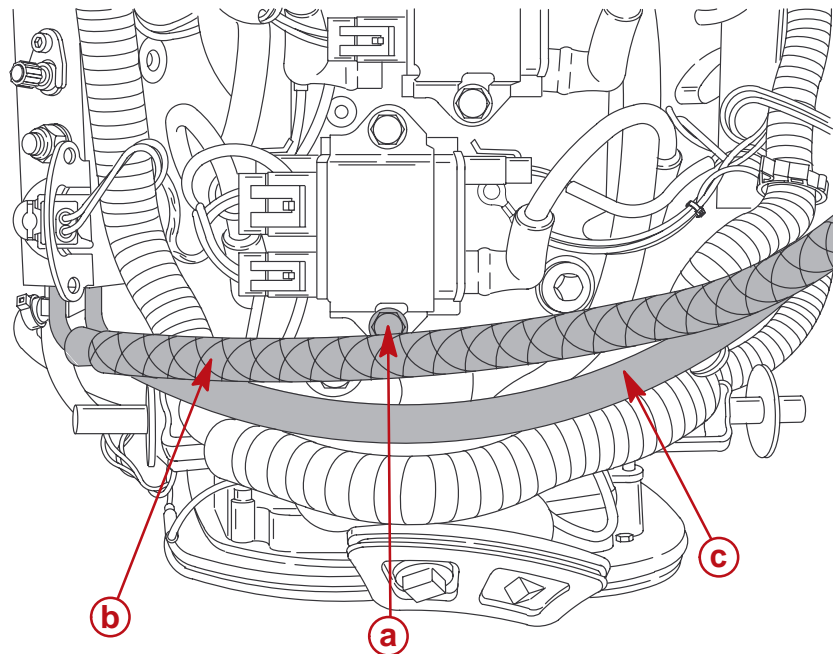
58807

The fuel balance hose between the port and starboard fuel rail could come in contact with an ignition coil driver mounting bolt. This could cause the hose to wear/chafe, at the point of contact with the bolt. If allowed to continue, this could cause a fuel leak.

- a** - Coil driver mounting bolt (may contact fuel hose)
- b** - Fuel balance hose
- c** - Air balance hose

Use the following steps to route the fuel balance hose away from the mounting bolt.

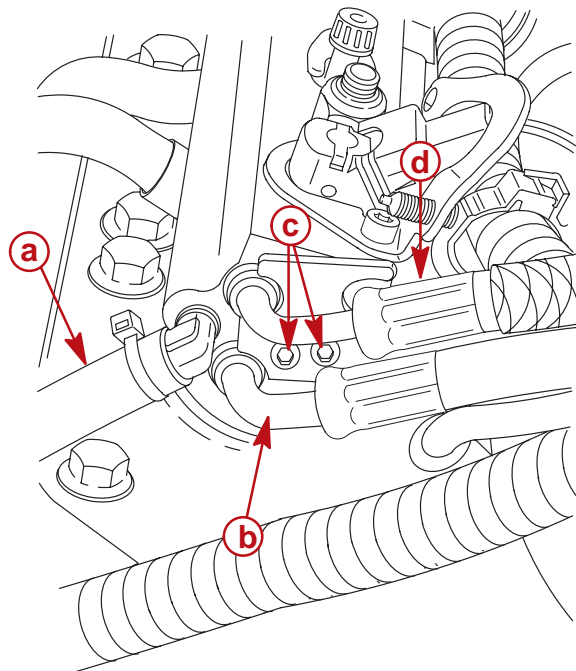
Port Bottom Fuel Rail Connections

- a** - Water inlet hose to fuel rail
- b** - Air balance hose
- c** - Allen screws (remove)
- d** - Fuel balance hose

- Remove the top and bottom cowls.
- Remove the two allen head bolts, and hose retainer plate from the bottom of the port fuel rail.

- Pull both the fuel and air balance hoses out of the rail.

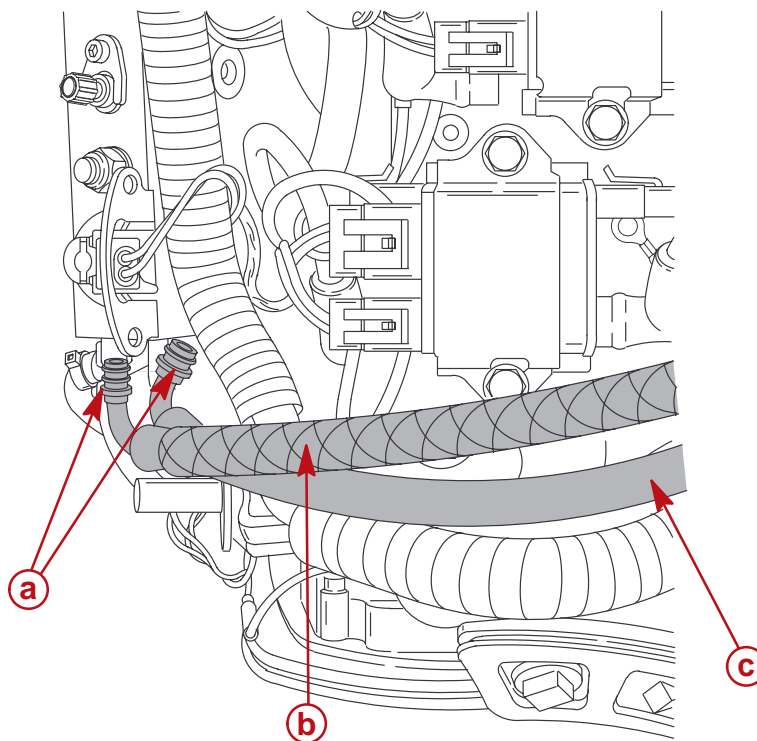
58808

- a** - Connector O-rings, coat with 4-stroke oil before assembling
- b** - Fuel balance hose
- c** - Air balance hose

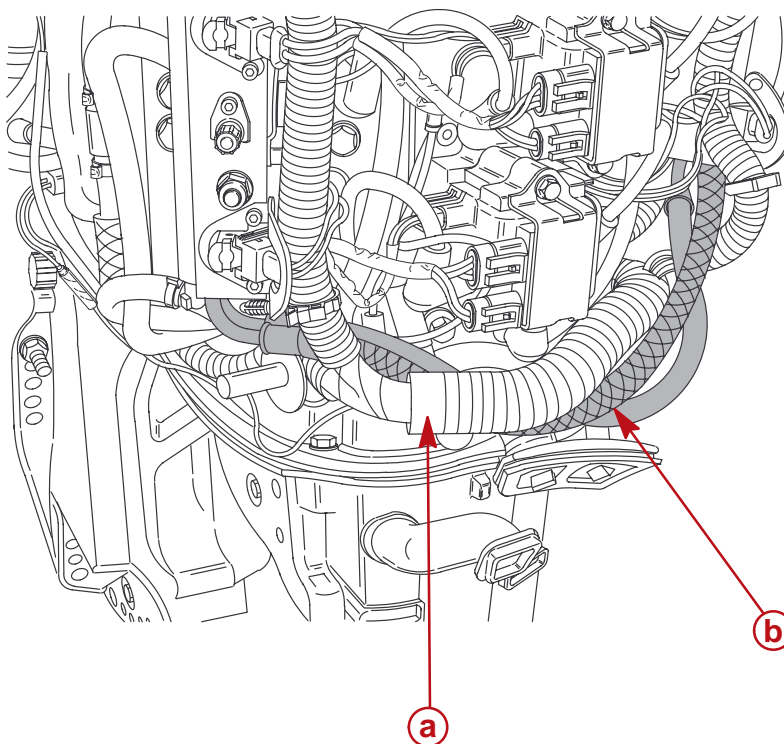
58809

- a** - Wire harness
- b** - Balance hoses

- Route the fuel and air balance hoses around the outside of the engine wire harness, as shown below.

- Insert the hoses into the bottom of the port rail
- Install retainer plate and allen bolts, (torque bolts to 70 lb-in [8 Nm])
