Water Tube Guide Causing Engine Overheating - 40 (3 Cyl.) Big Foot & 40 thru 60 Four Stroke

MERCURY/MARINER

Four Stroke Models

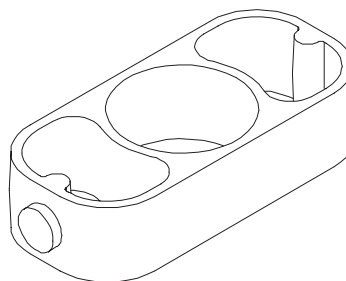
Water Tube Guide

The nylon water tube guide (54-828529) that is assembled in the drive shaft housing on affected four-stroke outboards may not be installed properly. If the water tube guide is not in place or has shifted out of the locking holes, the water tube coupler is no longer held down on the water pump housing. The water tube coupler may then work its way off of the water pump housing outlet. When the water tube coupler loses the seal to the water pump outlet, it will cause a loss of water supply to the engine.

The affected engines may overheat at idle and the tell tale stream may be weak or non-existent. The engine may not overheat at full throttle because of the higher water pump volume and the water tube coupler may have only moved slightly off of the water pump housing. At full throttle the tell tale may look normal.

If the engine overheats at all running conditions the water tube coupler may be completely off of the water pump housing. This would be indicated by no tell tale stream.

Normal installation: Slip the guide over the water tube, slide the guide up the water tube into the drive shaft housing. When the guide is even with the locating holes in the drive shaft housing, turn the guide 90° until the tabs on the guide interlock fully in the holes. With the water tube guide installed properly, the water tube coupler will not be allowed to move up the water tube.

Quantity 1 Part Number 54-828529 Water Tube Guide.

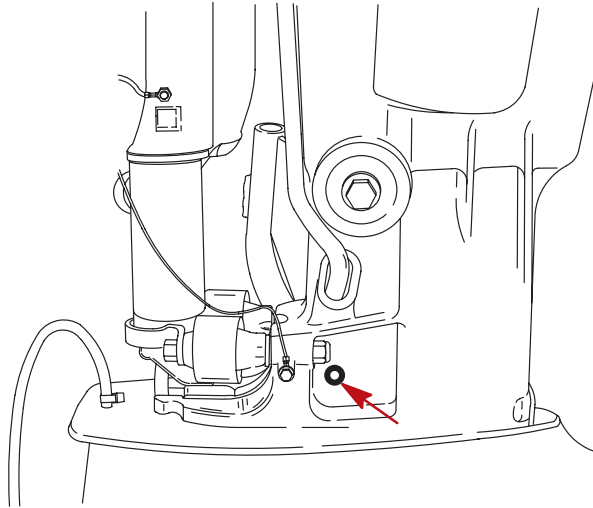
Location of Water Tube Guide Holes

Without Gearcase Removal: With the lower cowls removed, proper installation can be verified by carefully observing that the water tube guide tabs are inserted fully into the holes on both sides of the drive shaft housing.

With Gearcase Removal: Remove the gearcase from the drive shaft housing. Check that the water tube guide is in the proper place and the locating tabs are locked into the holes of the drive shaft housing.

1. Extra aluminum material in the holes of the drive shaft housing that prevents the guide tabs to be installed securely.
 - To fix this situation clean out the holes with a drill and a 1/4 in. (6.5 mm) drill bit.
2. Damaged guide tabs that can not be fully inserted into the drive shaft housing holes.
 - The only fix of this situation is to replace the water tube guide.

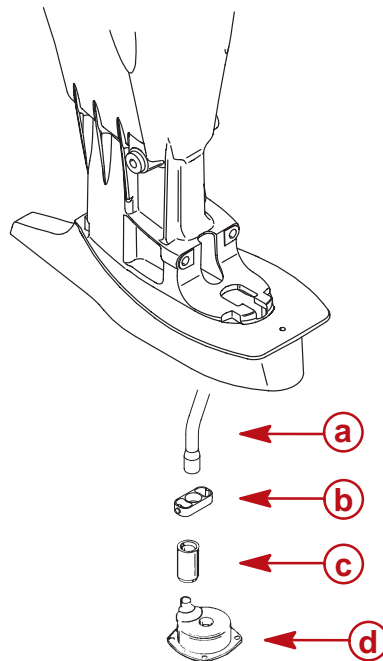
- a** - Water Tube
- b** - Water Tube Guide
- c** - Water Tube Coupler
- d** - Water Pump Housing

Service Tip: Secure the water tube coupler to the water pump outlet. Clean all grease and oil from the inside of the water tube coupler and the outside of the water pump housing outlet. Apply an instant adhesive such as Loctite 405 (obtain locally) to the inside of the coupler that will contact the water pump housing outlet. This will aid in holding the water tube coupler on the water pump housing outlet.

DO NOT glue both ends of the water tube coupler in place or later disassembly may not be possible.
