service bulletin

Bulletin No. 2002-07

Spark Plug Fouling 3.0 Liter OptiMax

MERCURY/MARINER
2001/2002 Model 200/225 3.0 Liter OptiMax
0T178500 Thru 0T598999

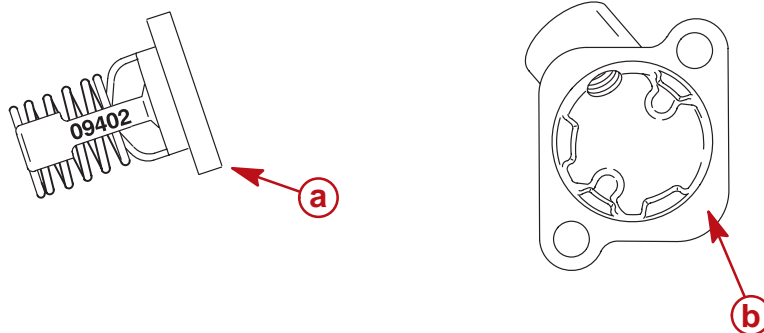
59179

A new 54° C [130° F] thermostat and new thermostat cover have been developed that will help maintain a higher engine temperature and reduce the chance of debris holding the thermostat open. A thermostat held open by debris would reduce engine temperature causing spark plug fouling. If an engine is in for a spark plug fouling condition, install thermostat kit **P/N 885599A1**. This kit includes all of the covers, thermostats and gaskets to upgrade one engine.

- a** - Seal is bonded to the new thermostat to prevent leakage around seal
- b** - New covers with narrow thermostat lands, allow MOST debris to pass through the system

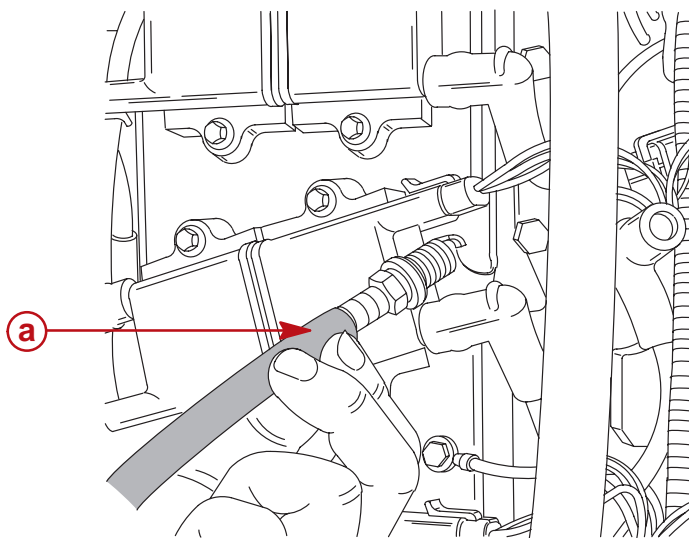
a - Rubber hose slid over spark plug for installation of plug

NOTE: To prevent spark plug cross threading, use a piece of hose pushed over the plug. (Gray fuel hose with 8 mm [.315 in.] I.D. works well.) This will allow you to thread the plug into the spark plug hole by hand while avoiding cross-threading. Torque plugs to 27 Nm [20 lbs. ft.].

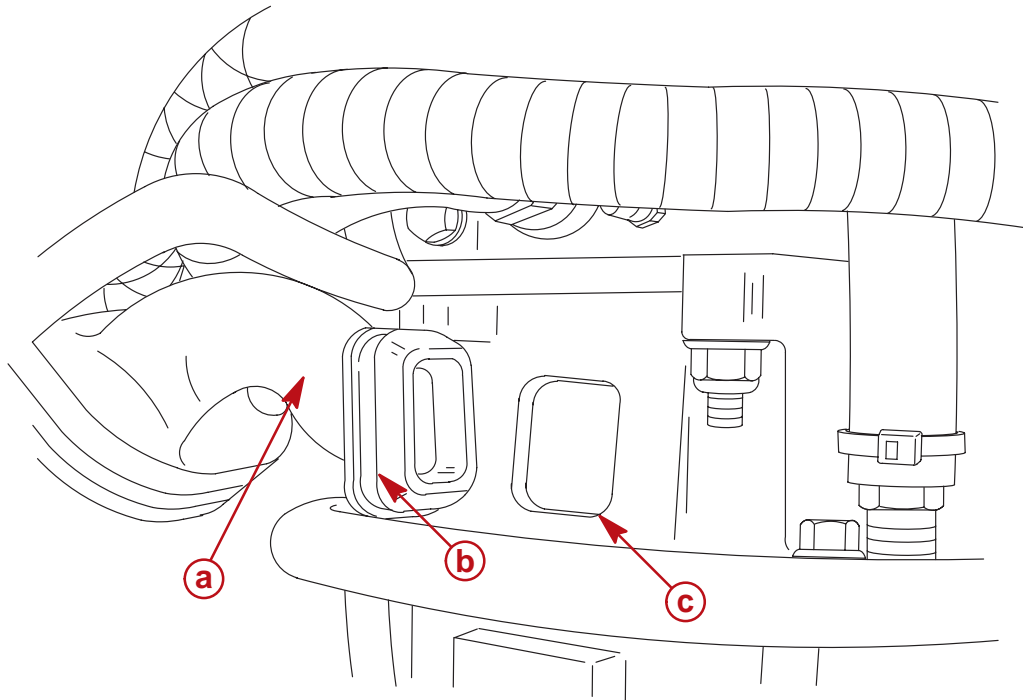
59484

Check for exhaust or water leaking from the exhaust boot where it connects to the adapter plate. When the engine is running at idle speed, put slight side pressure on the boot near the adapter plate. If you see water or exhaust leaking/spitting out between the boot and adapter plate the boot is leaking and needs to be resealed. A leaking exhaust boot will cause exhaust gases to be ingested into the engine when running with the cowl on, contributing to spark plug fouling.

- a** - Idle exhaust relief boot
- b** - Apply sealant completely around this area of exhaust boot
- c** - Idle exhaust boot opening in adapter plate, clean prior to installation

Remove the boot from the adapter plate. Clean the area of the boot and adapter plate where the two join together. Both surfaces must be clean and dry (no oily residue). Glue the boot back in using Loctite Ultra Copper RTV, available locally.

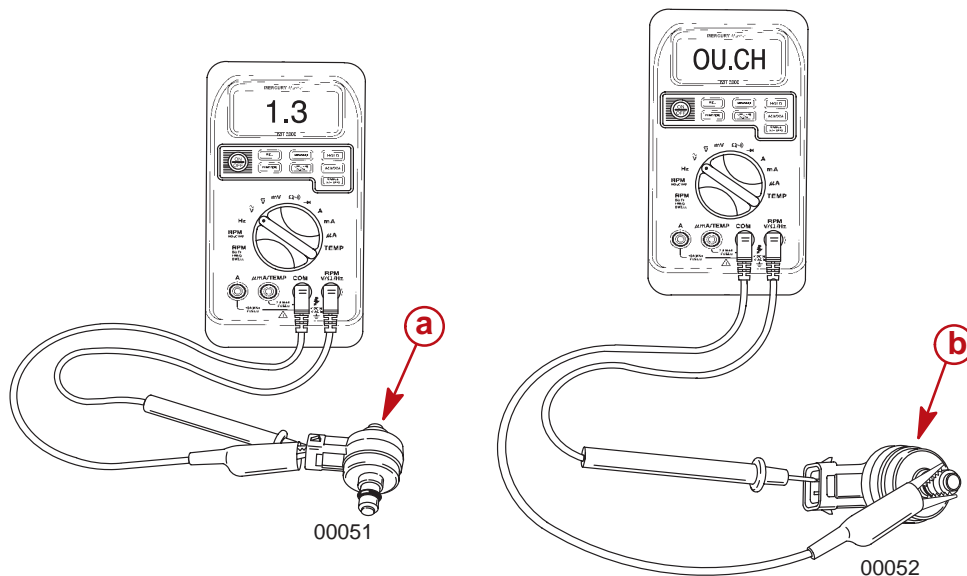
Check the resistance (ohms value) of the direct injector coil winding and determine if there is a short-circuit between the winding and engine ground. Incorrect ohms reading or a shorted winding will cause an incorrect fuel/air spray pattern, contributing to spark plug fouling. The correct reading should be between 1.0 and 1.6 ohms. If the reading is inaccurate replace the injector.

- a** - Direct injector ohm test between the two connector pins (1.0 - 1.6 ohms)
- b** - Direct injector short to ground ohm test (no continuity), check between either connector pin and the metal portion of the injector
