Bulletin No. 2004-07

## Installation of Neoprene Wrap 1.5 L OptiMax

Models Covered	Serial Number or Year
1.5 Liter OptiMax 75/90/115 hp	0T801000 and above

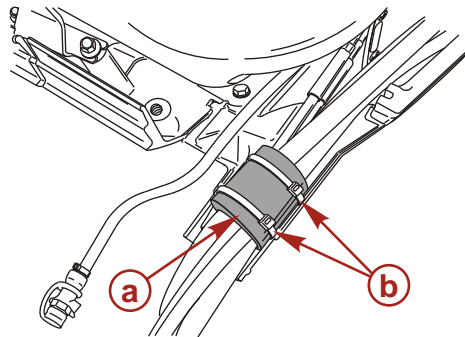
The control cables, harness, fuel hose, etc. have a neoprene wrap placed around them where they enter the bottom cowl. If the neoprene wrap does not fit tightly enough, it may be drawn or sucked into the power head compartment, ending up in front of the reed valves or throttle plate, restricting the air flow. The restriction can result in a loss of top RPM, spark plug fouling, engine stalling, or a no start condition.

Position the neoprene wrap as shown in the sketch below and place 2 cable ties around the neoprene wrap to hold it in place. Install the cable ties near the front and rear edge of the neoprene wrap.

**a** - Neoprene wrap

**b** - Cable ties (2)
