Official Recall Notification United States Federal Boat Safety Act Throttle Linkage Rod Replacement

Models Covered	Serial Number Or Year
225 V-6 EFI FourStroke	0T653945 through 1B055871

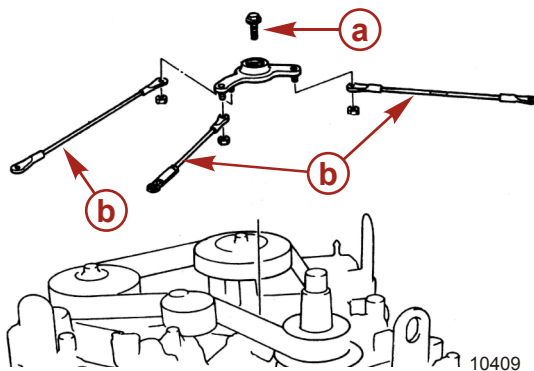
The engines identified above are at risk for throttle sticking. This risk exists even if the repair work from service bulletin 2003-09 has already been performed. As with the previous service bulletin, this failure could result in the engine not returning all the way to idle after running at an elevated RPM level, in either forward or reverse, when pulling the remote control throttle lever back to the neutral position. This may cause the engine to stay at a fast idle speed (1200-2000 RPM), which may prevent the operator from disengaging the shift mechanism and shifting into neutral.

A replacement Link Rod Kit (888603A01) is required. This kit contains updated link rods that have been improved to prevent sticking in the ball joint area of the link rods.

- a - Bolt with washer
- b - Link rods
