## 3 Ram Power Trim Motor Water Leak

Models Covered	Serial Number
Mercury/Mariner 135–200 OptiMax	1B804695–1B807280

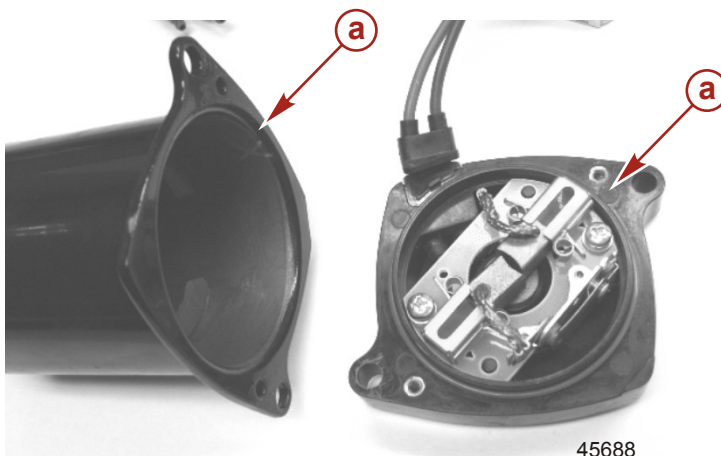
45688

Mercury Marine has determined the seal on some power trim motors may allow water to enter the power trim system which can damage the motor and other internal components of the power trim system. Mercury Marine has identified the cause of this condition and has made appropriate changes to new power trim systems produced.

The performance of these affected units will gradually degrade, become sluggish, and will eventually cease to operate.

**a** - Seal located on motor base has a potential to leak due to an incorrect radius on the motor housing flange

Qty.	Description	Part Number
1	Power trim motor assembly	8M0031551

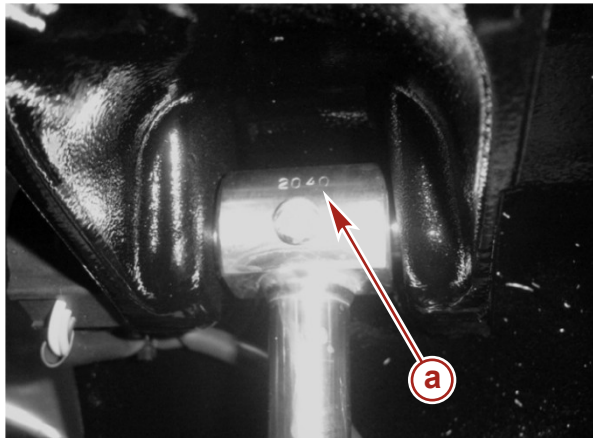
45689

Trim the engine completely up and engage the tilt lock lever. Look for the date code on the trim system located on the top of the ram eyelet just above the retaining pin.

**a** - The date code of 2040 is shown

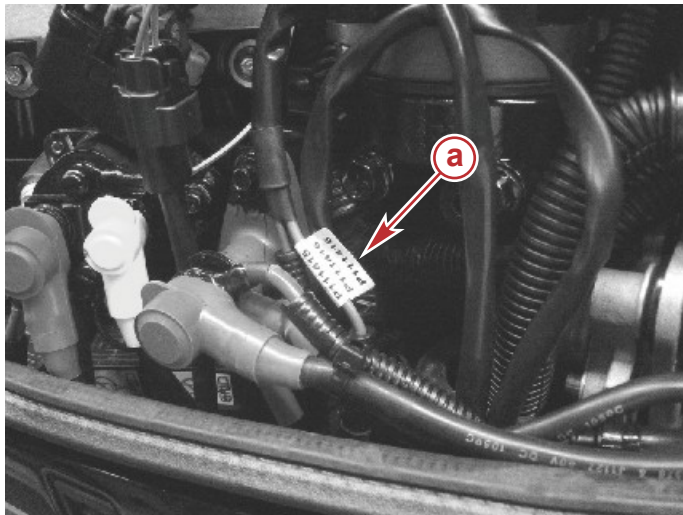
48399

The trim motor date code is located at the end of the motor leads under the cowl in the general area of the hot stud. Suspect power trim systems are within date codes 1370 –1730.

If the power trim is in the date code range, inspect the power trim motor assembly date code. The trim motor date code must be in the ranges of **P101117 through P101613** for trim motor replacement.

**a** - Date code location

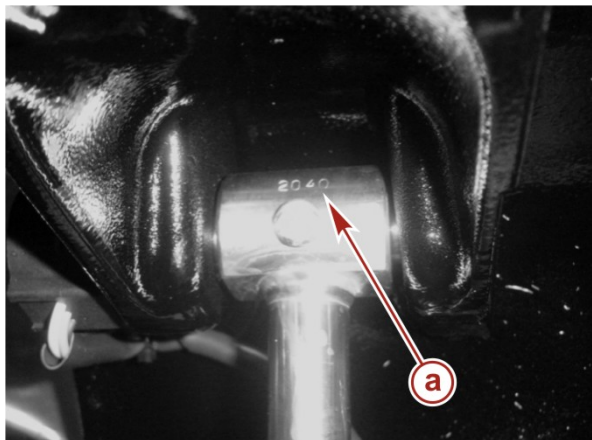
a – The date code of 2040 is shown

In the above photo you can see the date code of 2040.

Suspect power trim systems are within date codes 1370–1730.
