Supercharger System Troubleshooting—Verado L4 and Verado L6

NOTICE
This bulletin supersedes the previous service bulletin number 2009-16, November 2009.

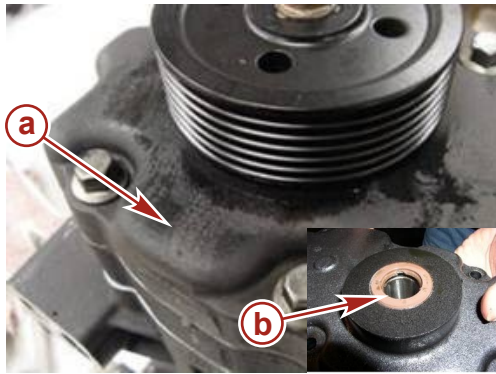
42667

- Oil leaking out of the top or front of the supercharger below the input pulley.

- a** - Oil present at top/front of supercharger
- b** - Input shaft seal

- Supercharger input shaft oil seal is leaking.
- Porosity or crack in the supercharger end cap.
- Engine oil is leaking at the upper crankshaft seal.

- If an oil leak is observed at the supercharger input shaft seal, install the supercharger end cap kit (8M0045222).
- If an oil leak is observed from a porosity hole in the supercharger end cap, install the supercharger end cap kit (8M0045222).
- If an oil leak is observed at the upper crankshaft seal, replace the upper crankshaft seal.

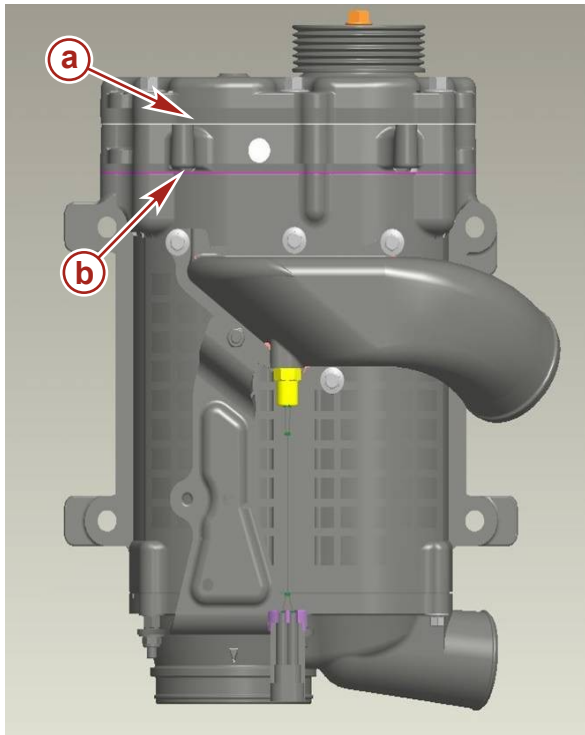
42668

- Oil leaking out of the supercharger bearing housing or end plate gasket joints.
- Oil is observed on the supercharger rotor housing.

- a** - Supercharger bearing housing to end cap joint
- b** - Supercharger rotor housing to bearing housing joint

- Clamp load on the supercharger end cap is low (loose bolts).
- Excessive oil carryover from the cam cover breather hose.

- If an oil leak is observed at the supercharger bearing housing to end cap joint, check the clamp load of the end cap bolts. Tighten the end cap mounting bolts to the specified torque.

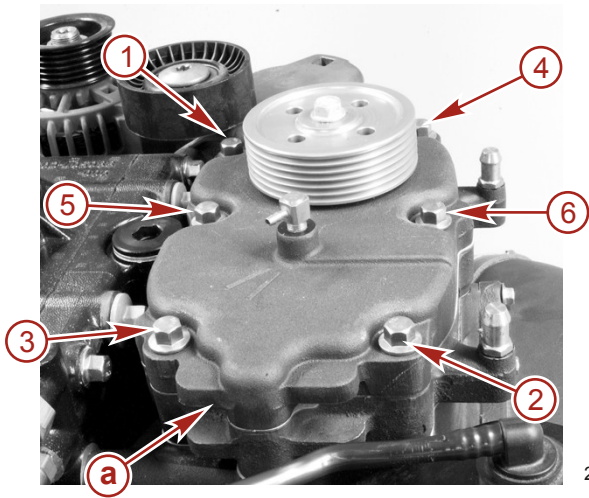
25689

a - Supercharger bearing housing to end cap

NOTE: Number 1–6 denotes the proper torque sequence.

Description		Nm	lb-in.	lb-ft
	End cap bolts	First	17	150.5
Final		35	–	25.8

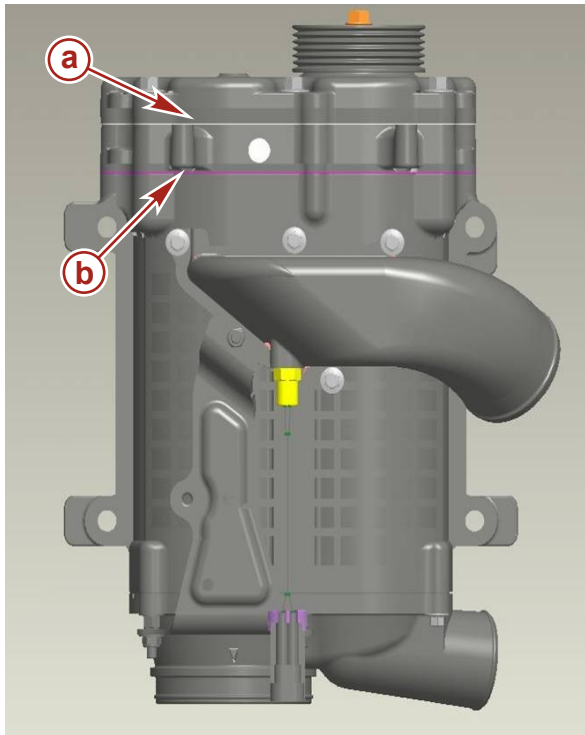
42668

- a** - Supercharger bearing housing to end cap joint
- b** - Supercharger rotor housing to bearing housing joint

- If an oil leak is observed at the supercharger rotor housing to bearing housing joint, replace the supercharger.

- If an oil leak is observed from porosity in the supercharger end cap, install the supercharger end cap kit (8M0045222).
- If an oil leak is observed at the upper crankshaft seal, replace the upper crankshaft seal.

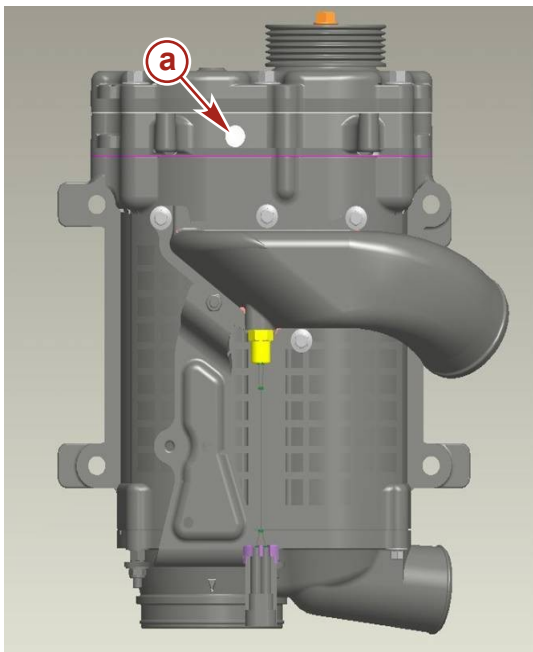
42669

- Oil leaking out of the front air vent of the supercharger.
- Oil leaking out of the supercharger rotor housing.

a - Front air vent filter of supercharger

- The rotor shaft oil seal is leaking or excessive oil carryover from the cam cover breather hose.

- If oil leak continues out of the air vent filter of the supercharger, replace the supercharger.

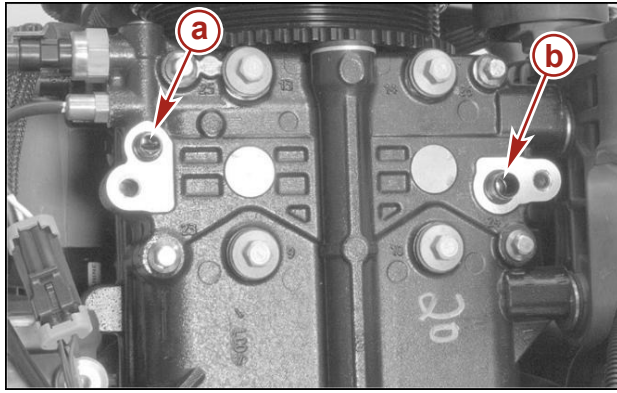
42670

- Oil leaking from the oil supply tubes between the engine crankcase and supercharger.
- Oil is observed on the rear of the supercharger rotor housing or engine crankcase.
- Leak occurs during operation or may form drips with the engine turned off.

- Oil supply tube O-rings are missing or damaged.

- Damaged supercharger mount feet, O-ring grooves, or damaged supply tube fittings.

a - Oil delivery O-ring and dowel pin (11 mm)

b - Oil return O-ring and dowel pin (14 mm)

- Remove the supercharger, inspect supply tubes and O-rings. Replace the O-rings and supply tubes as needed.
- Inspect the supercharger mount feet and O-ring grooves for damage. Replace the supercharger as required.

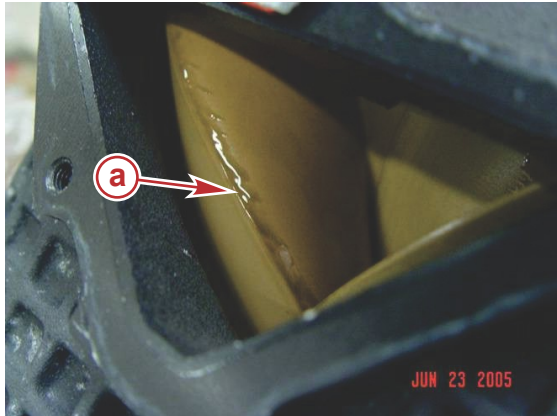
42671

- Engine burns oil.
- Engine smokes at start-up.

a - Oil on rotors

- Oil observed on supercharger rotors and in outlet duct to charge air cooler (CAC). Supercharger outlet duct housing removed.
- Excessive oil carryover from the cam cover breather hose.
- Bearing housing oil seal damage or leak.
- Excessive crankcase pressure stops oil drain back from the supercharger.

- If oil is observed upstream of the supercharger (intake resonator, inlet boot, or inlet duct), the problem is excessive oil carryover from the cam cover breather hose. The supercharger should not be replaced under these conditions.
- If no oil is observed upstream of the supercharger, remove the supercharger outlet duct and inspect for oil coverage on the rotors and outlet duct to the charge air cooler. If oil is present, replace the supercharger.

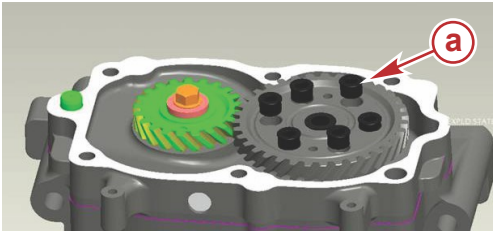
57593

- Noise or rattle between 1000–1300 RPM and noise goes away with the accessory drive belt removed.

- Worn bushings resulting in clearance between input drive pins and supercharger driven gear.

a - Bushing location

- If the noise is only audible with the cowl off or is difficult to hear with the cowl on, this condition is normal and is not detrimental to the supercharger or engine. No correction is needed.

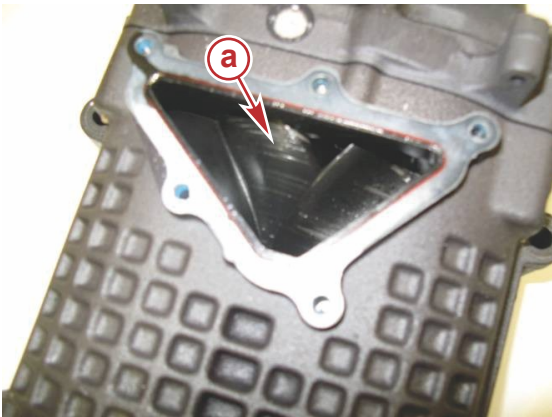
42673

- Noise that can be heard at all RPM levels with the cowl on, and noise level increases with RPM.

- Possible rotor to rotor contact.

a - Wear indicates rotor to rotor contact

- With the engine off, remove the accessory drive belt. Turn the supercharger pulley using a socket on a torque wrench. Tight spots of 10 Nm (88.5 lb-in.) or more indicate a problem.

- Low hour engines (less than 10 hours of operation) may emit noise due to a slight rotor to rotor coating contact. This condition may wear or break-in and is not detrimental to the supercharger. Monitor the noise level for the first 10 hours of operation.
- Possible internal gear problems.
- Possible bearing problems.
- Input shaft pins or bushings broken or missing.

- If noise level that remains constant or increases over the first 5–10 hours of engine operation indicates that the supercharger should be replaced.
- If noise level that diminishes after the first 5–10 hours of engine operation indicates supercharger rotor coating break-in. The supercharger should not be replaced under these conditions.
