No. 90-11

Wrong Diameter Water Hose Being Connected to 1-1/4 in. (32mm) Nipple on “Y” Connection

MCM D254 Turbo AC Stern Drive Engines

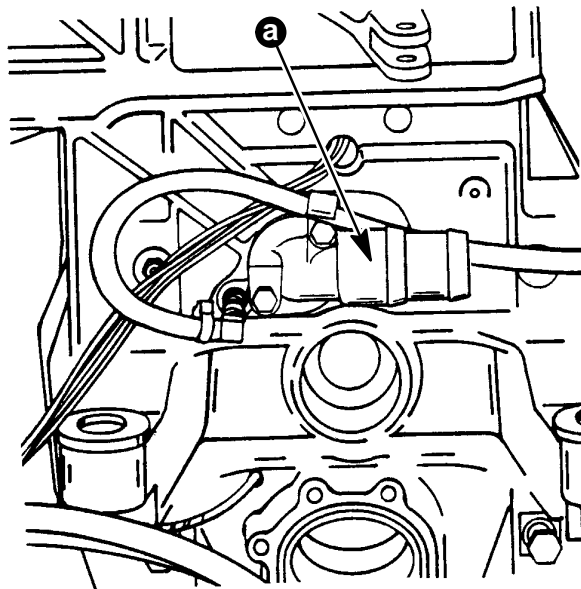
50939

a - 1-1/2 in. (38mm) I.D. hose installed on 1-1/2 in. (38mm) O.D. (second step) of water inlet fitting

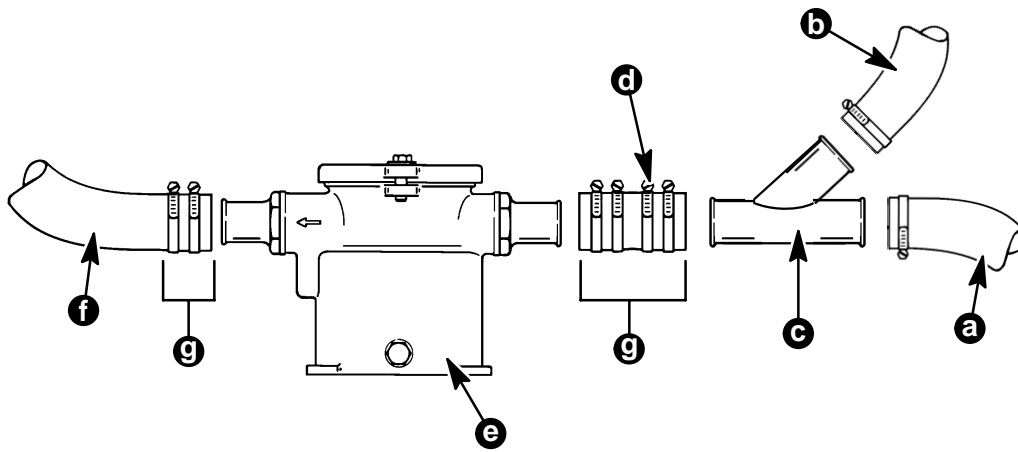
27699

- a - 1-1/2 in. (38mm) I.D. hose (from drive water inlet fitting) to 1-1/2 in. (38mm) O.D. "Y" fitting nipple
- b - 1-1/4 in. (32mm) I.D. hose (from auxiliary water pickup on transom) to 1-1/4 in. (32mm) O.D. "Y" fitting nipple
- c - "Y" fitting
- d - 1-1/2 in. (38mm) I.D. hose (to seawater strainer) connected to 1-1/2 in. (38mm) O.D. "Y" fitting nipple
- e - Seawater strainer
- f - 1-1/2 in. (38mm) I.D. hose (from engine) to 1-1/2 in. (38mm) O.D. fitting on strainer
- g - Double hose clamps. Early "Y" fitting will allow only a single clamp.
