No. 93-3

FIELD FIX NOTIFICATION

A. UNIVERSAL JOINT CROSS & BEARING CUP SEAL

Bravo One and Two

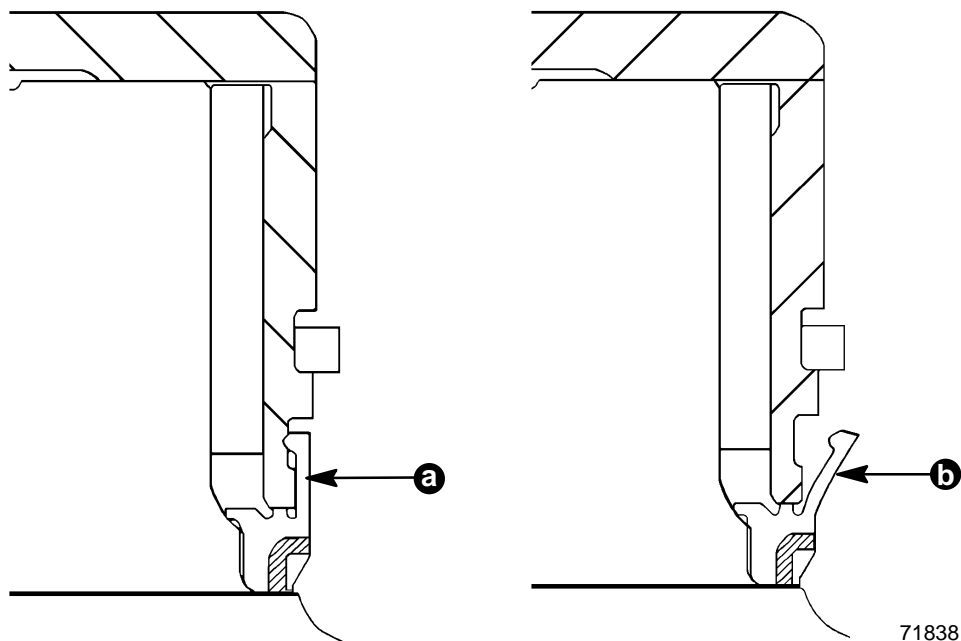
71838

The cup seal on the cross & bearing assembly may be made of the wrong material. When the seal comes in contact with grease, it swells and distorts as shown in the art work following, letter (b) represents the bad seal and letter (a) represents the good seal in appearance. There is a possibility of one or more bad seals on a unit, and not all units will have a bad seal. The serial numbered units listed on the following sheet need to be inspected for this problem defect. Although these defective seals present no danger for the owner or any passengers, their failure could result in premature failure of the universal joint.

a - good seal
b - seal defect

To correct the problem, remove the drive and inspect the universal joint assembly. Replace any cross & bearing assembly that has a defective seal with a new cross & bearing assembly, part number **75832A3**. Return the defective cross assembly that has the bad seal along with a warranty claim to your normal warranty processing location to receive credit.
