No. 93-13

Mercarb 2 Barrel Carburetor

New Float Setting

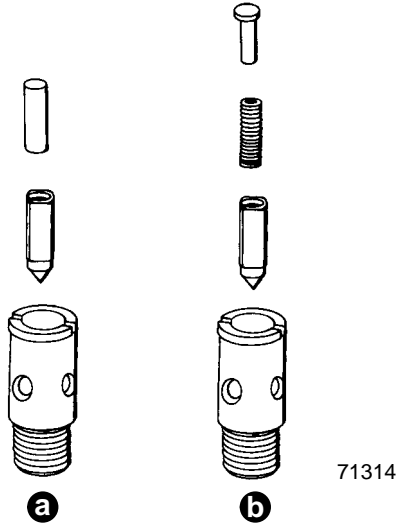
If all these items have been checked then you may want to check the type of needle and seat installed in the carburetor. Most MerCarbs use a solid two piece needle. The 3.0L carb P/N 1389-815396_ and 3.0LX carb P/N 1389-815397_ use a spring loaded needle.

- a - Solid Two Piece Needle
- b - Spring Loaded Needle

Installing a spring loaded needle and seat kit on a 4 cylinder engine can cause a “lean out” condition in extremely hard turns. (GM 153, 181 CID: Right turn, Mercury 224 CID: Left turn). V6 and V8 engines should not be affected. Because of this potential “lean out” condition in extremely hard turns, you should make the boat owner aware of this condition before installing the spring loaded needle.

If the carburetor has a solid two piece needle in it, install the spring loaded needle and seat kit. Reset float level to specification listed before.

The spring loaded needle is the preferred one to use if you have a flooding problem at idle RPM.

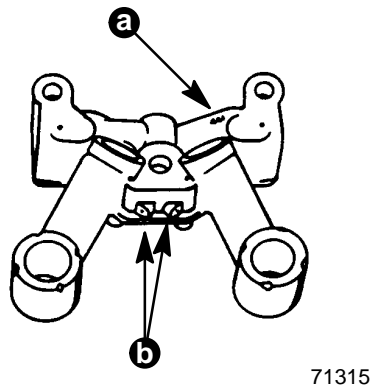
The venturi clusters are matched to the carburetor that they come in. Some time the replacement clusters get packaged wrong. The clusters have an identifying number on them. Refer to chart for carburetor/cluster use.

- a - Identification Number
- b - Accelerator Pump Discharge Holes

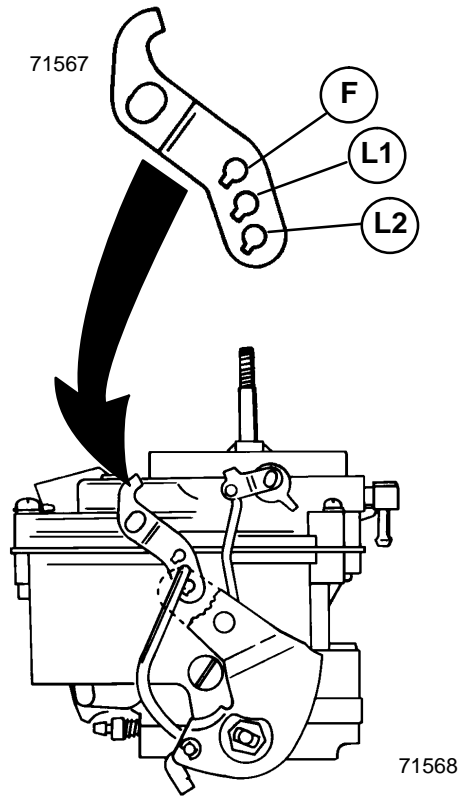
This new 3 holed lever will allow you to change the amount of fuel delivered to the engine by the accelerator pump. The hole closest to the lever's shaft, will give the same amount of fuel as the single hole lever did. The center hole gives approximately 0.5cc less fuel and the hole farthest away will give about 1.0cc less fuel.

- F** - Full Accelerator Pump Stroke
- L1** - 0.5cc Less Fuel Per Stroke
- L2** - 1.0cc Less Fuel Per Stroke

The technician should be able to correct most “bogging” problems with this 3 hole lever providing the “bogging” condition is caused by the carburetor. When installing the 3 hole lever, remove any metal ball that someone may have put in the accelerator pump well to limit pump travel. Also, make sure that the duration spring on the accelerator pump is stock and hasn't had several coils cut off. Make sure the venturi cluster is the correct one as outlined previously under “Identification”.

When installing this new lever in a carburetor that has a single hole lever, put the rod in the center hole. This will give 0.5cc less fuel to the engine on acceleration, than the single hole lever did. Test run boat in the water to see if bog has been corrected. Rod can be moved to other holes to richen or lean the pump stroke.

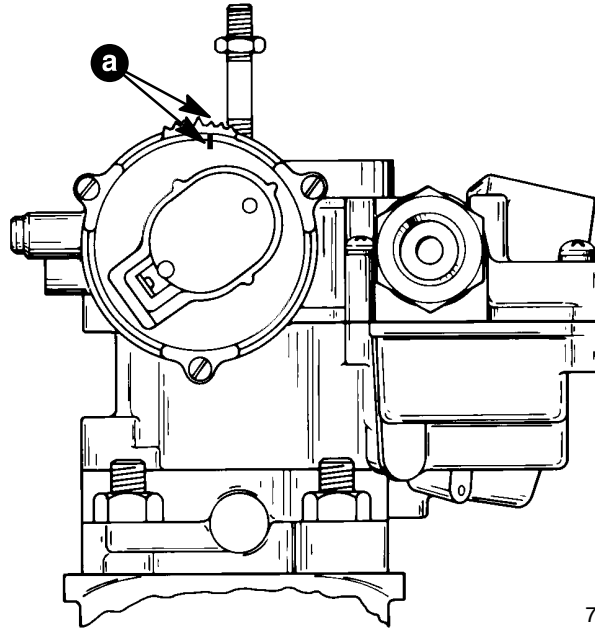
a - 1 Notch Clockwise (Leaner)
3302-808706 Venturi Cluster

When servicing the engine, the choke should be reset to the new choke setting which is 1 notch clockwise (leaner) as shown in drawing. The old setting was too “rich” for most conditions. Production is setting new engines to this new specification.
