**No. 94-10**

## OFFICIAL NOTIFICATION UNDER THE U.S. FEDERAL BOAT SAFETY ACT

### A. REQUIRED ENGINE GROUNDING STUD REPLACEMENT

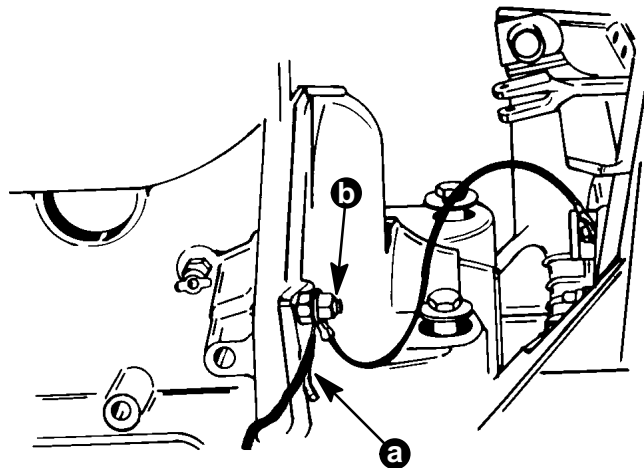
71651

The 2 battery cable ground studs, located on the flywheel end of these engines, may not conduct a sufficient amount of electric current to ensure an adequate electrical ground. Without a good electrical ground, the electric choke grounding wire in the engine wiring harness could overheat and be damaged when the starter motor is engaged. This damaged ground wire could combine with gasoline fumes in the bilge to create a fire or explosion. See figure for the location of these 2 grounding studs.

- a - Negative (-) Battery Cable.
- b - Ground Stud (One Each Side of Engine). GRAY = Change, GOLD = Already Changed.  
Stud Torque: 27 lb. ft. (37 N.m.).

**DO NOT use manifold bolts or any other bolts on the engine for a negative battery cable ground location if that bolt is GRAY in color. In some cases, this GRAY color has been painted over. The only way to determine the bolt's color, is to remove it and look at the unpainted surface. The GRAY color is the coating that is put on that bolt or stud. This GRAY coating is the reason that the bolts or the studs may not be conductive to ground.**

Look at color of both grounding studs. If the grounding stud is gold in color it does not need to be changed. If the grounding stud is gray in color, it does need to be changed. Remove the gray stud and replace it with the gold colored stud supplied by Mercury Marine.

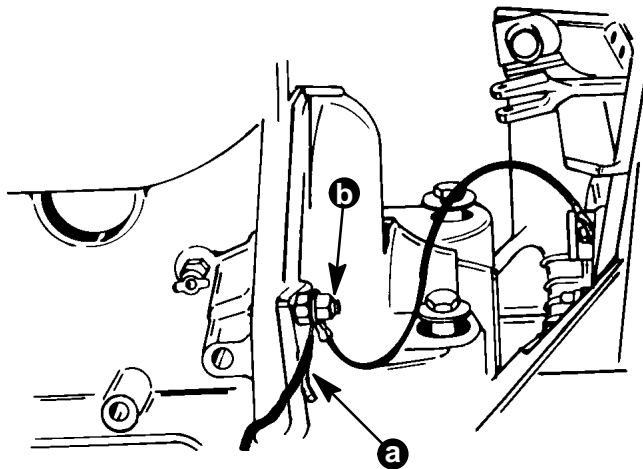
71651

Your engine ground studs may not conduct a sufficient amount of electric current to ensure an adequate electrical ground. Without a good electrical ground, the electric choke grounding wire in your engine harness could overheat and damage the wire.

- a - Negative (-) Battery Cable.
- b - Ground Stud (One Each Side of Engine). GRAY = Change, GOLD = Already Changed.  
Stud Torque: 27 lb. ft. (37 N.m.).

To determine if your engine is affected, the ground studs must be inspected. This can either be done by you or by your MerCruiser Dealer. The studs are located at the rear of the engine on either side of the flywheel housing (see diagram below). The easiest way to find the stud is to locate the negative battery cable at the battery and trace it to the engine ground stud. If the studs are a bright gold/bronze color they do not need to be replaced. In that circumstance, please fill out the enclosed reply card and return it to us by mail. If the studs are a dull gray color, make arrangements with your MerCruiser Dealer to have the studs replaced before you use your boat. If you do not wish to make the inspection yourself, please make arrangements to have the inspection made by your MerCruiser Dealer.
