MERCROISER SERVICE BULLETIN

Section: XII (Bulletins)
Number: 68-167-14
Date : 9/20/67

- A. MerCruiser Engine Alignment - 4 & 6-Cyl. (P. 9A, Sec. 11)
- B. Engine Alignment Shaft (C-91-48247) (P. 9A of Section 11)

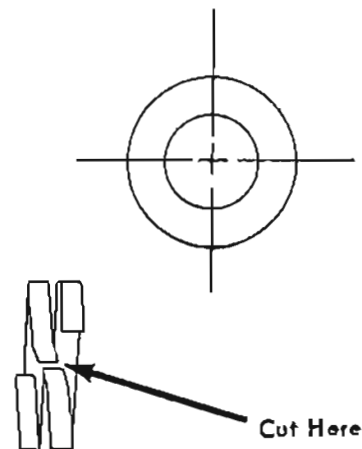
Figure 1. Cut of Special Spring Lockwasher

To help overcome misalignment, made at the time of engine installation, the engine height on MerCruiser 120 (Serial No. 2050045 and up) and MerCruiser 160 (2051445 and up) have been lowered $3/32''$ (2.4mm) via the narrow spacers above the engine mounts in the flywheel cover.

To lower the engine height on all MerCruiser 110, 140, 150, 60 diesel and 120's below Serial No. 2050045 and 160's below Serial No. 2051445, cut the special, double-wound spring lockwasher (B-13-33734) in half, which has the same result as installing the new spacers. (Figure 1) DO NOT CUT THE SPECIAL LOCKWASHER ON MERC 120 and 160 ENGINES ABOVE THE SERIAL NUMBERS LISTED HERE.
