MERCURUISER SERVICE BULLETIN

Section: XII (Service
Bulletins)
Number: 863-02
Date: 3/27/63

- A. MerCruiser Marine Engine Code Numbers
- B. New MerCruiser Service Tool (Oil Drain Pump)
- C. Bell Housing to Gimbal Housing - Water Inlet Hose Positioning - MerCruiser I
- D. Reverse Hook Release Lever - MerCruiser I

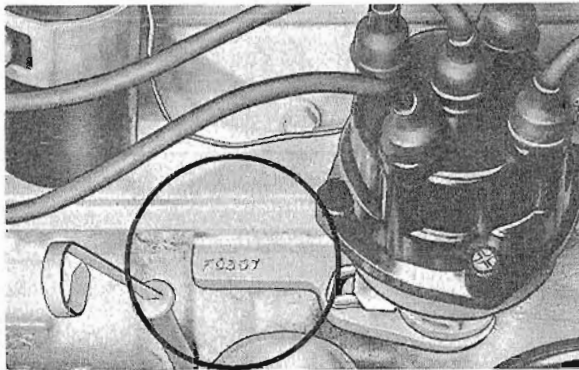
Figure 1

Effective immediately, when filling out "Applications for Adjustment of Warranty Material and Labor" on MerCruiser Marine Engines, "Engine Code Number" must be listed after "Engine Serial Number", and "Hours of Operation" also must be given. Any claims received without "Code Number" and "Hours of Operation" will be rejected and returned. On "110" and "140" engines, the code number is located on the cylinder block next to the distributor. (Fig. 1) On "190", "225" and "310" engines, the code number is located at the right front edge of the cylinder block on the cylinder head mounting flange. (Fig. 2)

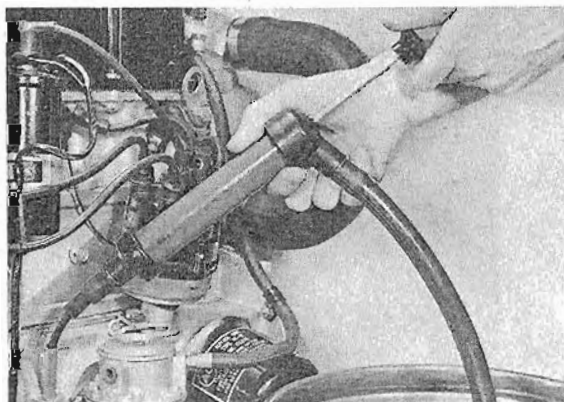
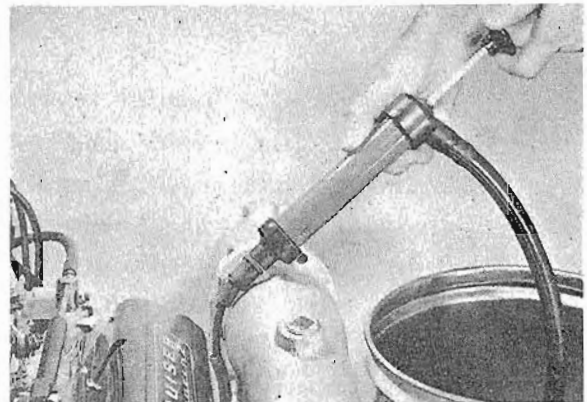
Pump is used for removing crankcase oil on all MerCruiser Marine Engines. Pump pick-up tube fits inside dip stick hole on engine. Eliminates draining problems on all boats. (Figures 3 and 4)

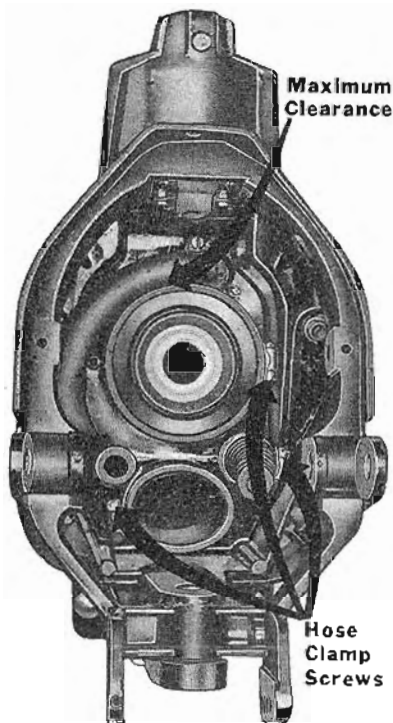
Care should be exercised during the installation of the water inlet hose (32-32461), located between the bell housing and gimbal housing, so that the hose will not be cut or a hole will not be worn into the hose. Improper installation of the water hose will allow it to kink or rub during the normal steering action of the drive unit.

Install water inlet hose so that the natural curve of the hose follows the contour of the universal joint bellows and allows maximum clearance, as shown in Figure 5.

Position universal joint bellow clamps and exhaust bellow clamps, as shown in Figure 5 and 6, so the clamp screw head does not touch water inlet hose during maximum turning.
