MERCURISER SERVICE BULLETIN

Section: VI (Alternator System)

Number: 63-03 ~~63-04~~

- A. Alternator System Voltage Regulators and Alternator Connections
- B. Installation of Voltage Regulator and Mounting Bracket
- C. MerCruiser I and II Stern Drive Unit Tilt Switch Connections

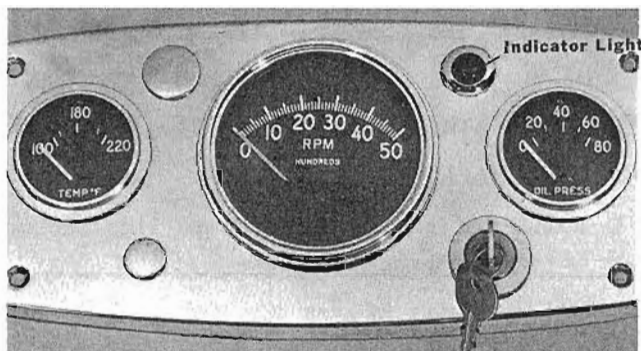
Figure 1

1. Instrument panels, which have a charging indicator light mounted in panel (Figure 1) must use Voltage Regulator No. 32702. This regulator can be identified by number "506" in regulator base. The engine wiring harness is connected to regulator, shown in Fig. 2, and harness must be connected to alternator, shown in Fig. 3.

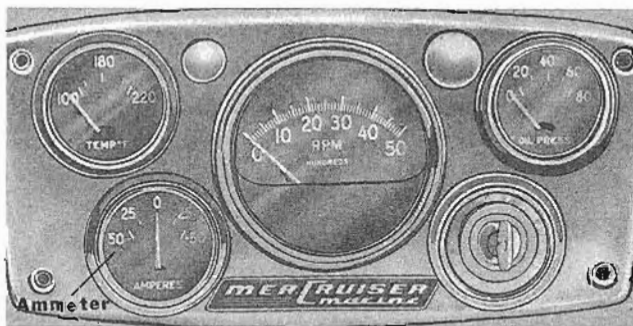
Figure 4

2. Instrument panels, which have an ammeter mounted in panel (Figure 4), must use Voltage Regulator No. 34141. This regulator is identified by a number "507" in regulator base

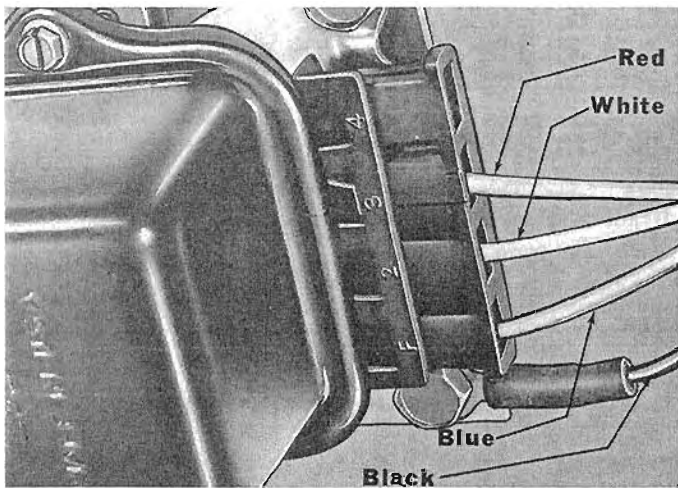
Figure 5

Engine wiring harness is different than harness used with indicator light system and is connected to regulator as shown in Figure 5. Harness must be connected to alternator as shown in Figure 6.
