# MERCUISER SERVICE BULLETIN

Number: 65-310

Date : 7/23/65

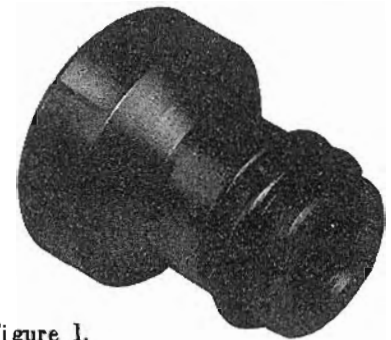
Figure 1.  
Lubricant Recirculating Device  
Removal Tool (C-91-39281)

A tool is now available (Figure 1) which removes the lubricant recirculating device in MerCruiser I E-Z Shift gear housing assemblies. Remove lubricant recirculating device by installing Sleeve Tool (C-91-39281) into grooves of sleeve (left hand thread). Thread end of Slide Hammer Puller (C-91-34569A1) into sleeve tool and tap sleeve out of gear housing.

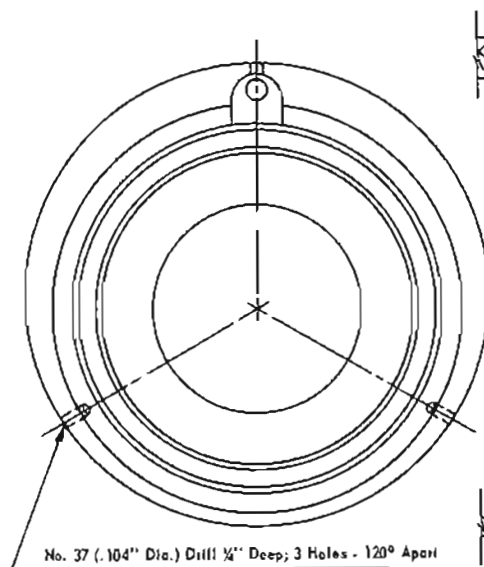
Figure 2. Position of Drive Screws in Gimbal Housing

When repairing MerCruiser IA-IB-IC stern drive units, install drive screws (C-10-25612) in universal joint bellows flange on both bell housing and gimbal housing. Installation of the drive screws provides a more positive means of fastening the bellows to the flanges. Later production drive units will have the drive screws already installed.

To install drive screws, position screws in flanges in approximate location shown in Figures 2 and 3. Holes can be drilled by placing a right angle drill adaptor on a drill.

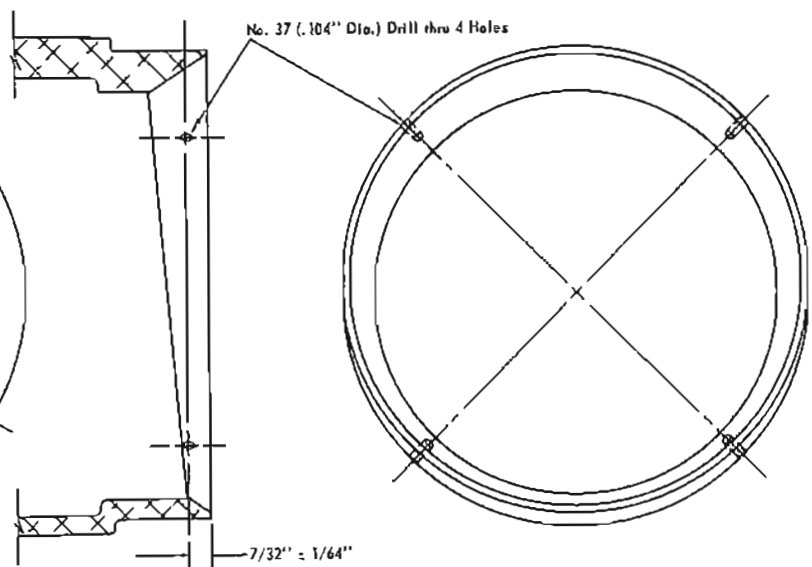
Figure 3. Position of Drive Screws in Bell Housing

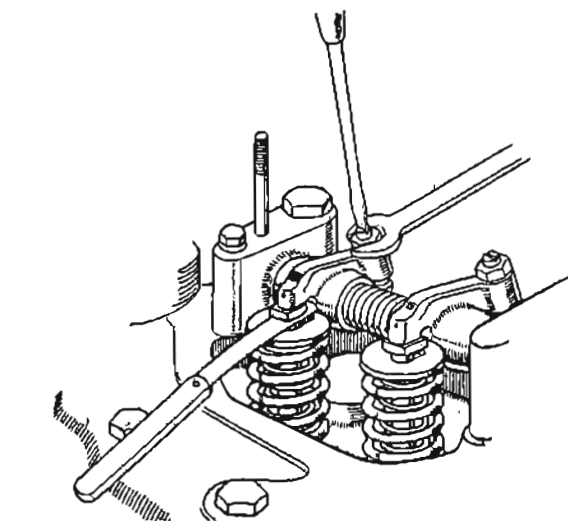
It is of the utmost importance that tappet clearances be maintained at the correct figure; that is, .010" (0.25mm) on all valves, with engine either cold or at running temperatures. Less clearance will result in reduced power output, while greater clearance will mean noisy tappets. Tappets, therefore, must be adjusted after the first 20 hours of operation and every 100 hours thereafter.

Figure 4. Adjusting Tappets

To adjust tappets, proceed as follows: (Figure 4)

1. Turn crankshaft in direction of rotation until No. 8 valve (counting from forward end of engine) is fully open. In this position, tappet for No. 1 valve is on dwell of its cam and is in correct position for checking.
2. Check No. 1 tappet clearance with .010" (0.25mm) feeler gauge inserted between rocker and valve stem. (Figure 4)
3. If adjustment is required, loosen locknut and rotate tappet adjusting screw until correct clearance is obtained. (Figure 4)
4. Retighten locknut. Be sure that this does not change clearance.
5. Repeat procedure for remaining valves in order shown below (tappets should be set in following order):

Set No. 1 tappet with No. 8 valve fully open.  
Set No. 3 tappet with No. 6 valve fully open.  
Set No. 5 tappet with No. 4 valve fully open.  
Set No. 2 tappet with No. 7 valve fully open.

Set No. 8 tappet with No. 1 valve fully open.  
Set No. 6 tappet with No. 3 valve fully open.  
Set No. 4 tappet with No. 5 valve fully open.  
Set No. 7 tappet with No. 2 valve fully open.
