# MERCUISER SERVICE BULLETIN

Number: 68-18 14

Date : 9/6/68

## A. EXHAUST SYSTEM INSTALLATION - MerCruiser II and III

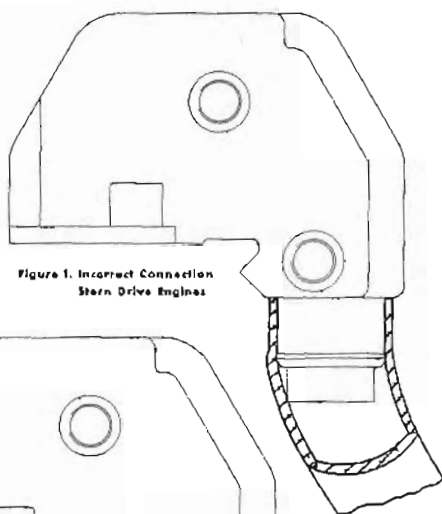
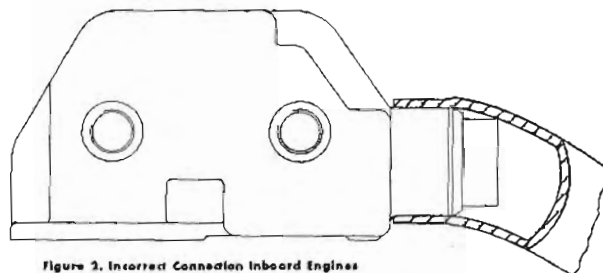
Hoses, which are connected as shown in Figures 1 and 2, will prevent discharge water from flowing around the entire inside diameter of the hose and will cause a hot spot which may burn thru.

Figure 1. Incorrect Connection Stern Drive Engines

Figure 2. Incorrect Connection Inboard Engines

Hoses must be connected as shown in Figures 3 and 4. It is recommended that these hoses be checked when servicing the model engines listed in the first paragraph.

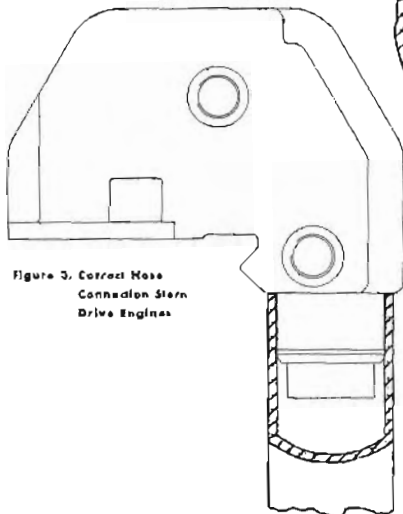
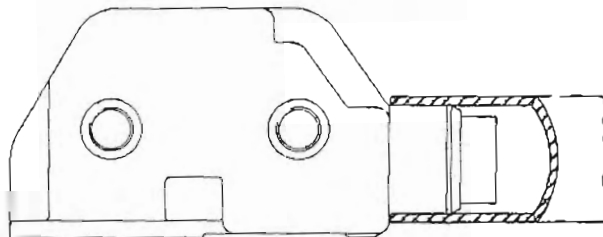
Figure 3. Correct Hose Connection Stern Drive Engines

Figure 4. Correct Hose Connection Inboard Engines

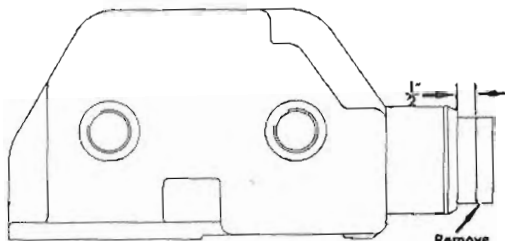
Figure 5. Water Deflector Modification

If an exhaust hose has burned thru, both hoses should be removed from the elbows and water deflector length checked. If deflectors protrude from elbow over  $\frac{1}{2}$ " (12.7mm), remove material from deflector as shown in Figure 5. Install new hoses as shown in Figure 3 or 4.

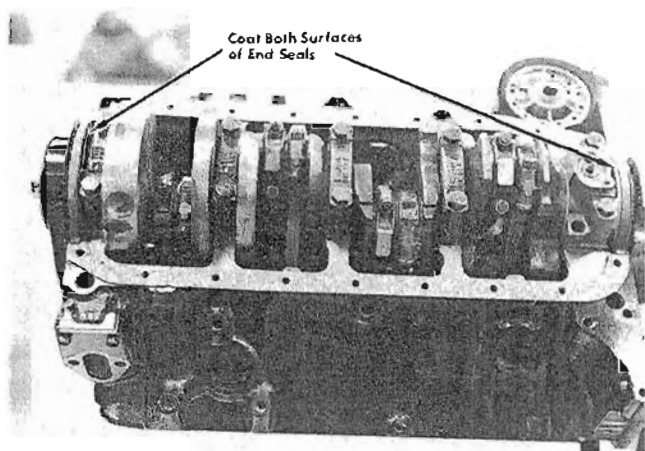
Figure 6. V-8 Oil Pan Seals

Before installing the aluminum oil pan on MerCruiser V-8 engines, coat the surfaces of the front and rear oil pan seals (Figure 6) with Oil Pan Sealant (C-92-52238-1).

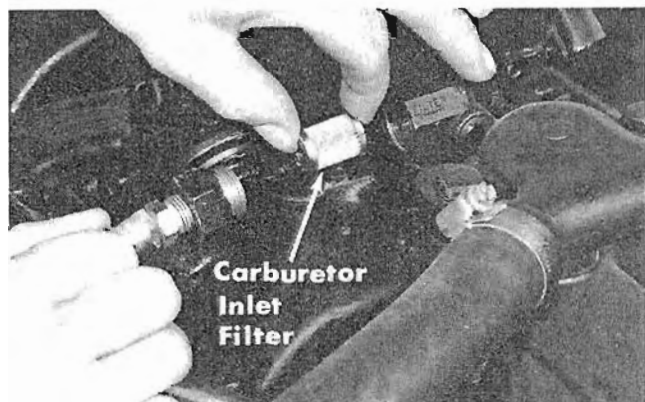
It has been found in some cases that the fuel inlet filter, located inside Quadrajet Carburetors used on MerCruiser Engines with Serial No. 2314316 and below, does not allow sufficient fuel flow and may cause erratic engine operation. The filters on these engines should be replaced with a new filter (B-35-53386) if erratic engine operation is found and also when servicing these engines.

Figure 7. Quadrajet Fuel Inlet Filter

MerCruiser Engines, equipped with Quadrajet Carburetors and between Serial Nos. 2314317 and 2494935, do not have a fuel inlet filter installed in the carburetor. When servicing these engines, it is recommended that the new filter (B-35-53386) and spring (B-24-48143) be installed as shown in Figure 7.
