MERCROUISER SERVICE BULLETIN

Number: 69-8-02

Date : 1/14/69

- A. Tightening Clamp Nut - MerCr. 200-225 (For Section II)
- B. MerCruiser II Drive Unit Installation (For Section II)
- C. Locking MerCruiser 200-225 Clamp Nut (For Section II)

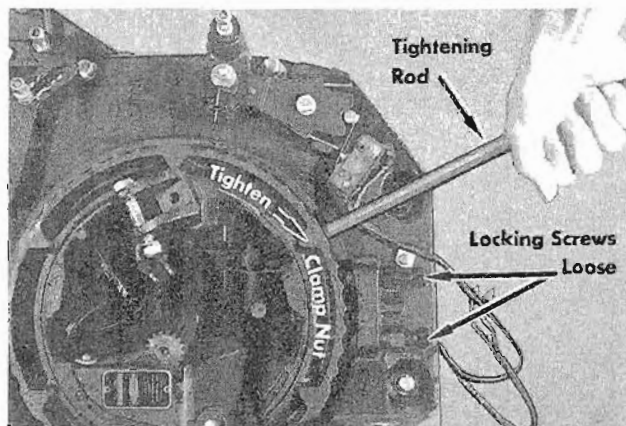
Figure 1. Clamp Nut Installation

Reports have been received that some MerCruiser 200 and 225 drive units will not remain tight in the transom plate after the clamp nut is tightened.

TIGHTEN CLAMP NUT SECURELY and SOLIDLY with TIGHTENING BAR (B-91-49670), ALIGNING CLAMP NUT FLUTES with LOCKING SCREWS. (Figure 1) SNUG LOCKING SCREWS and TIGHTEN LOCK NUTS. (Figure 2)

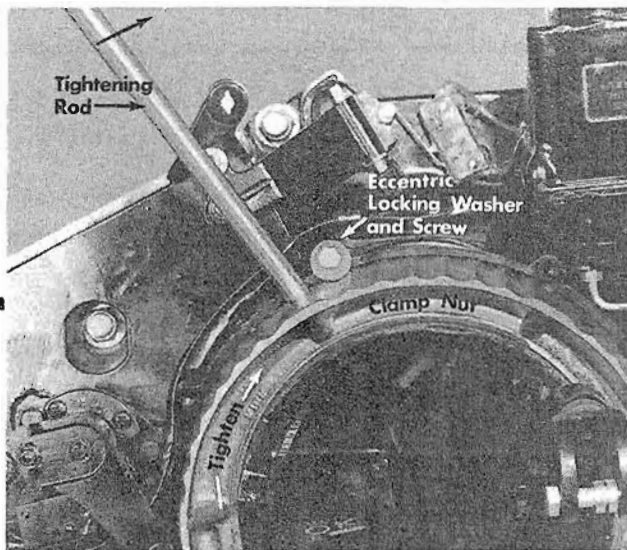
Figure 3. Installation of Eccentric Washer and Screw

Occasional communication reveals that some MerCruiser II (1.78:1) drive units will not tighten in the transom plates when the clamp nut is tightened.

drive unit. Check for 1) a broken locating pin which would keep the drive teeth in the steering lever housing from mating with the teeth in the transom plates, or 2) that the locating pin is installed off center. In either case, remove the locating pin and reinstall the drive, aligning it by sight to be vertical. Check the drive for proper engagement into the mating teeth of the transom plate. The drive unit will lock into the outer transom plate if the clamp nut is securely and solidly tightened with Tightening Bar (B-91-49670), aligning clamp nut flutes with locking washer and screw. (Figure 3)

Install new eccentric locking washer (B-12-54208) and screw (C-10-35192) on the inner transom plate of MerCruiser II (1.78:1) drive to retain clamp nut on units presently using regular flat washer. (Figure 3)
