MERCRUISER SERVICE BULLETIN

Number: 69-15

Date : 7/22/69

A. EXHAUST WATER SHUTTER NOISE - MerCruiser 120-140-160

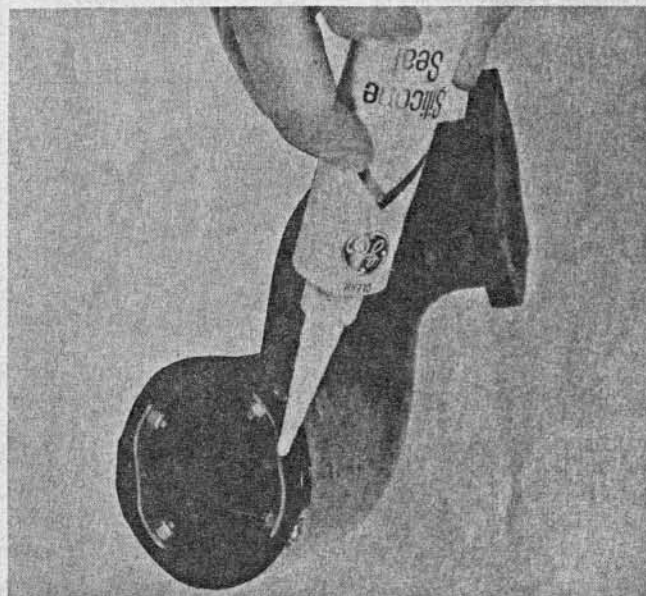
The exhaust water shutter, located in the MerCruiser 120-140-160 exhaust tube, may make a rattling noise at idle speed. This noise is caused by a loose fit between the shutter shaft and support brackets and can be corrected as follows:

Figure 1. Sealant Application

1. Loosen hose clamps which fasten exhaust bellows to exhaust tube.
2. Remove screws, which fasten exhaust elbow to manifold, and remove elbow and bellows. Scrape gasket material from manifold and elbow.
3. Thoroughly clean area between shutter support brackets and exhaust tube with cleaning solvent and a small brush or pipe cleaner.
4. Fill entire area between support brackets and tube with Sealant (C-92-52238-1). Allow sealant to cure for 24 hours. (Figure 1)
5. Reinstall elbow, using new gasket, and connect bellows. Tighten hose clamps securely.
