MERCRUISER SERVICE BULLETIN

Number: 69-15-11

Date : 7/22/69

A. EXHAUST WATER SHUTTER NOISE - MerCruiser 120-140-160

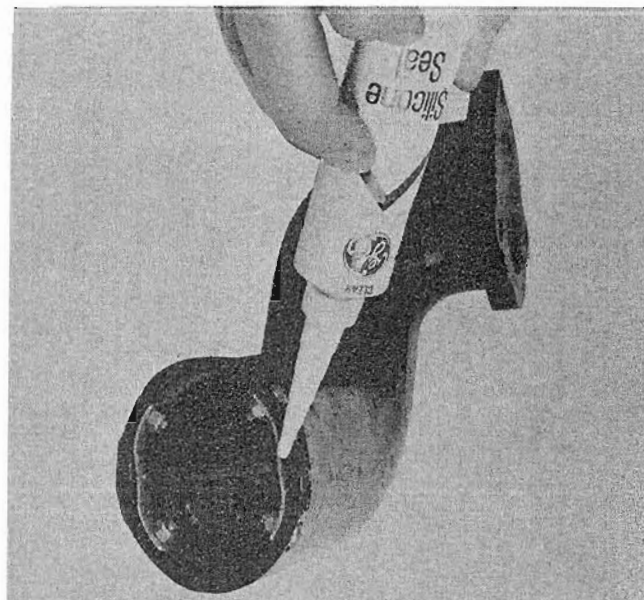
Figure 1. Sealant Application

The exhaust water shutter, located in the MerCruiser 120-140-160 exhaust tube, may make a rattling noise at idle speed. This noise is caused by a loose fit between the shutter shaft and support brackets and can be corrected as follows:

1. Loosen hose clamps which fasten exhaust bellows to exhaust tube.
2. Remove screws, which fasten exhaust elbow to manifold, and remove elbow and bellows. Scrape gasket material from manifold and elbow.
3. Thoroughly clean area between shutter support brackets and exhaust tube with cleaning solvent and a small brush or pipe cleaner.
4. Fill entire area between support brackets and tube with Sealant (C-92-52238-1). Allow sealant to cure for 24 hours. (Figure 1)
5. Reinstall elbow, using new gasket, and connect bellows. Tighten hose clamps securely.
