MERCURISER SERVICE BULLETIN

Number: 70-16-12

Date : 8/14/70

E. MERCUISER 215 GIMBAL HOUSING LEAKAGE (For Drive Units Section IX)

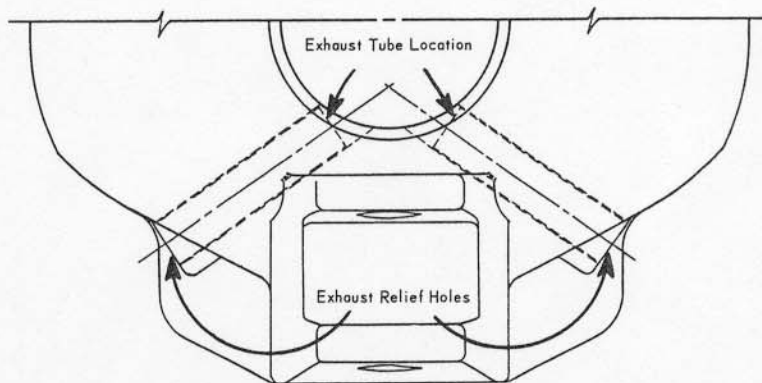
Figure 1. Exhaust Tube Location

Some gimbal housings have been found leaking thru the casting near the exhaust relief holes (located on bottom of housing near the exhaust elbows). To correct this problem, coat the sides of each hole with sealer (C-92-52238-1) and insert one tube (C-32-59563A1) into each exhaust relief hole as shown in Figure 1.
