- A. MerCruiser 888 Overheating
- B. MerCruiser 280II-TRS Stainless Steel Propellers
- C. New MerCathode Replacement Parts
- D. New Trim Limit Switch Replacement Procedure

A. MERCURISER 888 OVERHEATING

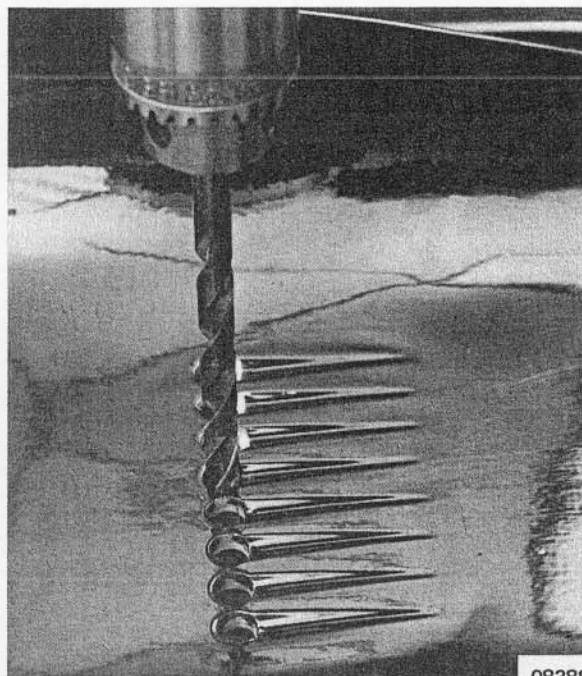
Figure 1. Drilling into Water Pickup Hole

If a MerCruiser 888 Engine, with drive unit Serial No. 3909578 and below, continues to run hot or overheats after the water pump impeller, thermostat, manifolds and engine condition have been checked, the gear housing can be modified to help remedy the condition. Drive units with Serial No. 3909579 and above have a new intake water screen and DO NOT need modification. Proceed with modification as follows:

1. Drill perpendicular into top water pickup hole with a 1/4" drill, allowing the drill to penetrate only slightly into the cavity. (Figure 1) Rotate the drill slowly toward the front of the gear housing, keeping it parallel to the cavitation plate until a 45° angle is reached. (Figure 2)

CAUTION: DO NOT allow the drill end to penetrate deeper than the housing wall thickness. Should the drill penetrate into the exhaust cavity, it would damage the gear housing beyond repair.
