No. 87-8

320 EFI Engine - Rich Idle

High Speed Water Pick-Up Inserts - Alpha One

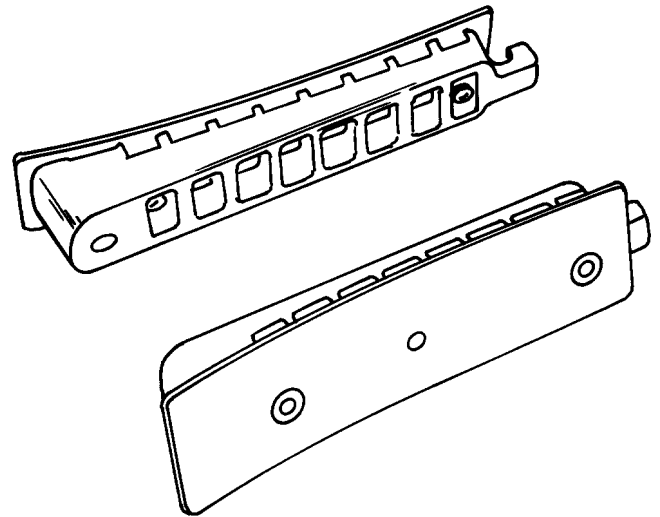
21248

There has been some reports received of V-8 engines with Alpha Drives overheating when installed in deep-vee performance hulls. All of the reported cases are boats with twin engines and capable of running 55 to 60 MPH plus. The overheating normally takes place with the engines running at W.O.T. and the drive units trimmed out. Aerated water is being forced into the cooling system which causes the engine to overheat. MerCruiser has designed a high speed water pick-up (Part No. 93423A2) as a direct replacement for the standard inserts, which may be used if the above conditions exist.

The use of high speed water pick-ups is recommended only in those cases where there is an indication of overheating due to gear case operating in an aerated water condition.

The use of this device increases the chance of debris getting caught in water inlet holes. Periodically inspect water inlet holes for debris.

Do not attempt to modify high speed water pick-ups, as this could render pick-ups ineffective and increase the possibility of high speed blow out and cavitation.
