No. 87-1

New Alternator Bracket to Fit MCM 120/140/2.5L and 3.0L Engines

Detonation Failures on 4 Cycle Engines

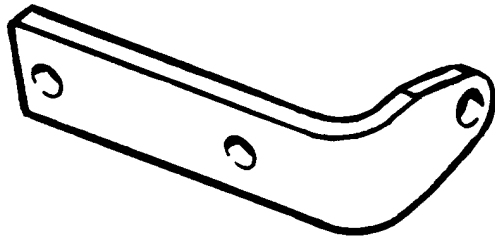
Figure 1. Old Bracket
Part No. 63857A2

MerCruiser Service has received some reports of alternator brackets breaking on 1986 and 1987 MCM 120/140/2.5L/and 3.0L engines. If a customer experiences a failure of an alternator bracket (Part No. 63857A2) it should be replaced with a new design bracket (Part No. 16738A1). The new bracket can be identified by an extra ear added for the alternator to mount in. (Figures 1 & 2).

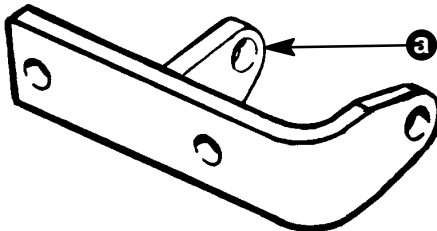
Figure 2. New Bracket
Part No. 16738A1

a - Ear Added to Bracket

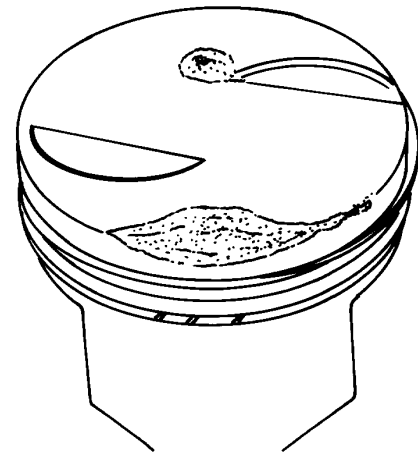
Figure 1.

In the last few months MerCruiser Service has received complaints of piston breakage on MCM and MIE engines. After further investigation it was determined the pistons did not break due to defect but were damaged from detonation.

1. Low octane fuel.
2. Too much spark timing (advance).
3. Engine running lean (fuel restriction and/or air leak).
4. Engine over propped (lugging).
5. Inadequate cooling of engine.
6. Excessive carbon build up.
7. A combination of 2 or more of the above.

Figures 1 & 2 show piston erosion. The erosion is caused by excessive heat which starts melting the piston.

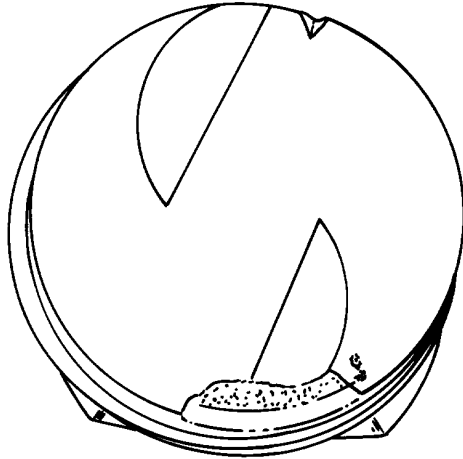
Figure 3.

Figures 3 & 4 show piston breakage. The breakage is caused by excessive combustion pressure which breaks pieces out of the top of the piston.
