No. 87-14

## Freeze Damage To MerCruiser Engines

## Sea Water Pickup Pump Failures - Both Drive Unit Mounted and Belt Driven Engine Mounted

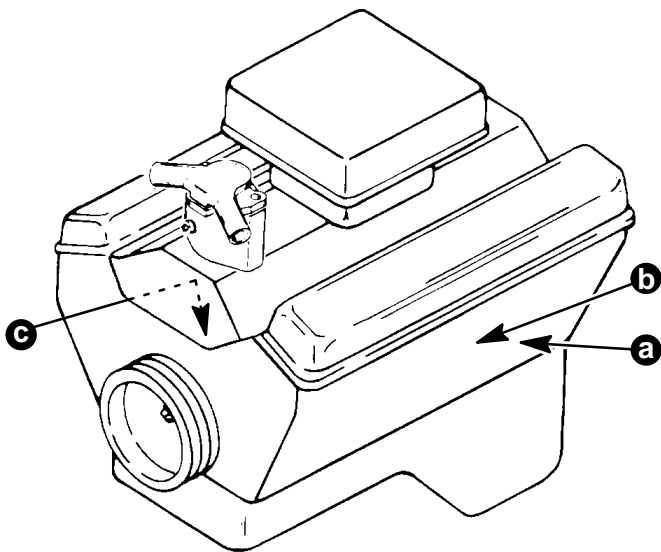
Freeze damage to MerCruiser engines is usually identified as a horizontal crack that has one edge of the crack pushed out slightly. A freeze crack in the cylinder block usually happens just below the core plugs or along the upper edge of the cylinder block just below the cylinder head (Figure 1). V-6 and V-8 engines can also crack below the intake manifold in the valley area of the block (Figure 1). Exhaust manifolds and exhaust elbows can also crack from freezing. Heat exchangers, oil coolers, and transmission fluid coolers that freeze can either crack a cooling tube internally or push out the end caps.

- a - Below Core Plugs
- b - Below Cylinder Head
- c - Under Intake Manifold Valley

If power package will not be used for an extended period of time or will be exposed to freezing ambient temperatures, drain water from cooling system, as explained in owners "Operation and Maintenance Manual". Water must be drained to prevent corrosion and freeze damage to engine.
