No. 87-13

Power Steering Bracket Modification When Installing Fresh Water Cooling on 1987 MCM 305/350 CID Engines

Oil Cooler Clamp Modification on MCM 575 Engines

MCM 420 Exhaust Pipe Baffles

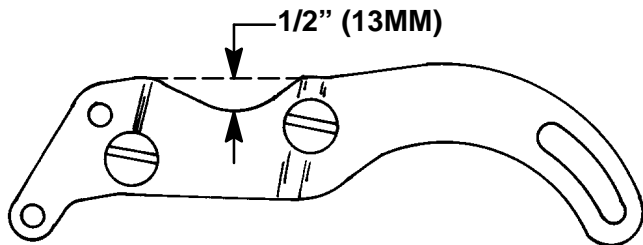
Some 1987 305/350 CID engines were produced with a power steering bracket that may interfere with the heat exchanger when installing fresh water cooling. If an interference does exist remove bracket and modify as shown in Figure 1. The bracket can be modified using a grinding wheel.

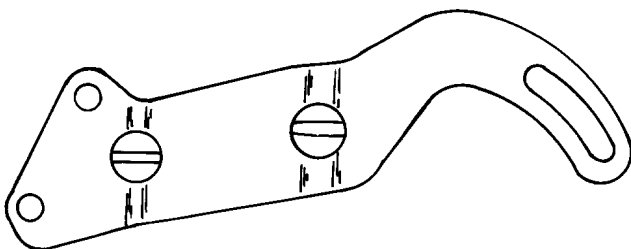
Figure 2.

Later engines are being produced with a redesigned bracket (Figure 2) which allows for greater clearance between the bracket and the heat exchanger.

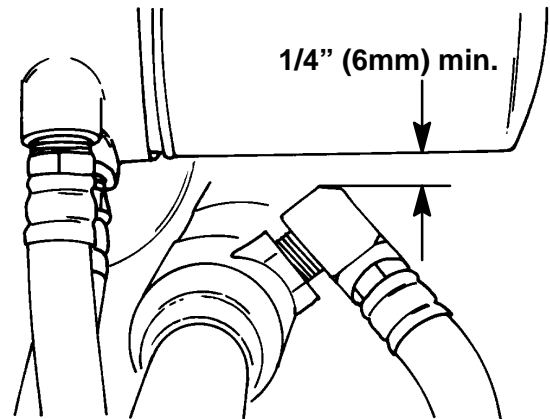
Figure 3.

MerCruiser has received a few isolated reports that the oil cooler has rotated in its mounting clamp. If this happens the fitting on the cooler rests against the oil filter and may possibly rub thru causing an oil leak and a possible loss of oil pressure. When servicing a 575 engine, remove the mounting clamp and place a self adhesive pad (Part No. 18068) on the inside of the upper half of the clamps. (Figure 3) Position cooler so there is a minimum of 1/4" (6mm) clearance between the oil cooler fitting and oil filter. (Figure 4) Install clamp and tighten securely.

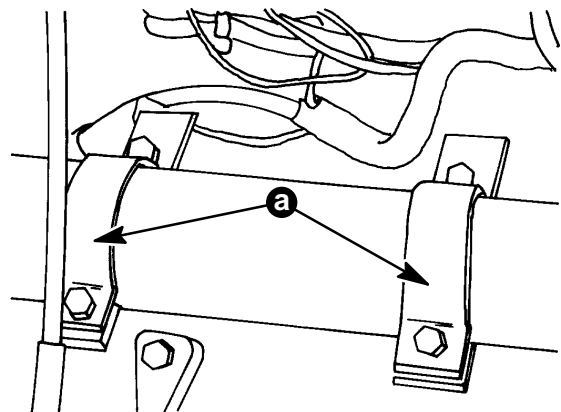
Figure 4.

a - Place Pad Under Each Upper Half of Clamp

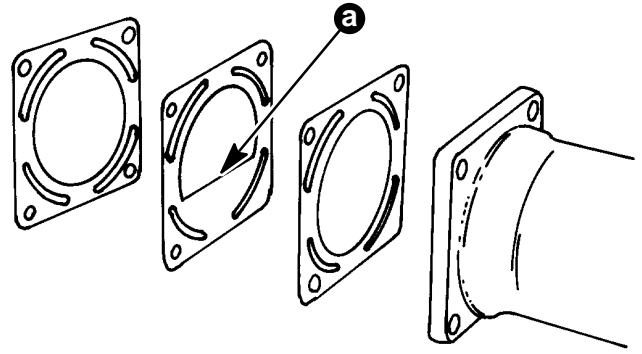
Under certain operating conditions, (usually when a high speed boat is decelerated rapidly) there is a chance water may be ingested into a 420 engine thru the exhaust system. To prevent this from happening MerCruiser has designed a baffle (Part No. 18069) that will fit between the exhaust elbow and exhaust pipe. (Figure 5)

a - Lip Must Face Towards Exhaust Pipe

IMPORTANT: The baffle must be sandwiched between two gaskets (Part No. 27-13848) as shown in Figure 5. Baffle must be Installed In direction shown.
