STERN DRIVES/INBOARD ENGINES

service bulletin

NUMBER: 81-7

- A. Auxiliary Hot Water Heater Return Kit (B-74567A1)
- B. Thermostat Recommendations -
All Models except MCM 470/485 and MIE 470
- C. Water Distribution Housing - MIE 470
- D. Use of RTV Sealant on MerCruiser Engines
- E. Exhaust Manifold Elbow Clogging

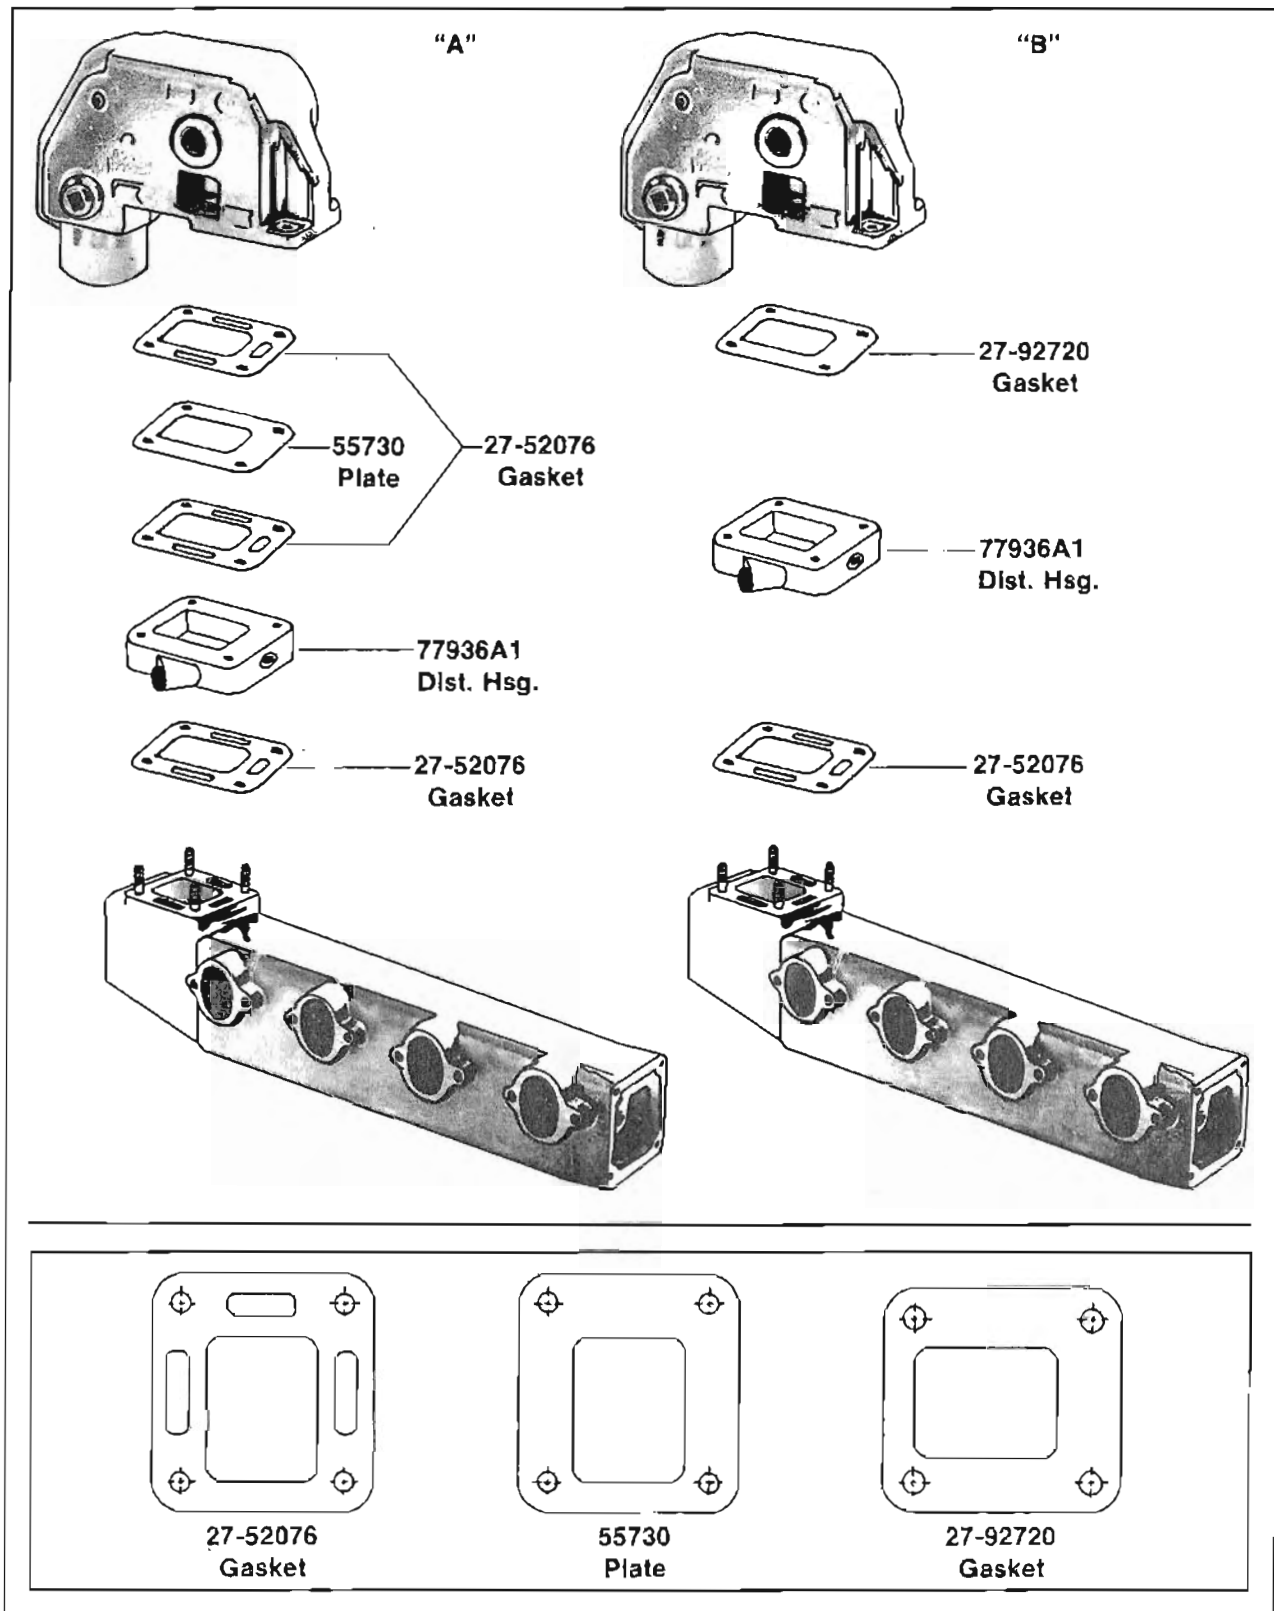
Figure 1. Water Distribution Housing Gasket Location

Early MIE 470 engines were produced with a water distribution housing (Part No. 77936A1) made of aluminum. The aluminum housings were assembled with two gaskets (Part No. 27-52076) and a plate (Part No. 55730) between the housing and exhaust elbow (Figure 1, Ref. 'A'). It has been reported that, in the course of changing exhaust elbows, the plate was omitted. This will cause rapid corrosion of the housing, and a loss of coolant.

On engines, Serial Number 5689234 and above, the housing (Part No. 77936A1) was made from cast iron. The two gasket/plate arrangement is used between the housing and exhaust elbow on these models. However, the two gaskets/plate may be omitted ONLY if gasket (Part No. 27-92720) is used between the cast iron water distribution housing and exhaust elbow (Figure 1, Ref. 'B').

The parts list for the MIE 470 engine shows one gasket Part No. 27-52076 (upper) between the water distribution housing and exhaust elbow; and one gasket Part No. 27-92720 (lower) between the water distribution housing and exhaust manifold. That gasket location is INCORRECT. The CORRECT location of the gaskets is shown in Figure 1, Ref. 'B'.
