STERN DRIVES/INBOARD ENGINES

NUMBER: 81-31

DATE: 11/27/81

- A. Anti-Siphon Devices Used In Conjunction With MerCruiser Engines
- B. Shift Lever Used On Borg-Warner In-Line or V-Drive Transmission
- MIE 230/260/340 and Later Production MIE 470 Engines
- C. Replacement Light Bulb for Micro-Card Viewer
- D. Ink Roller Replacement - Data Imprinter

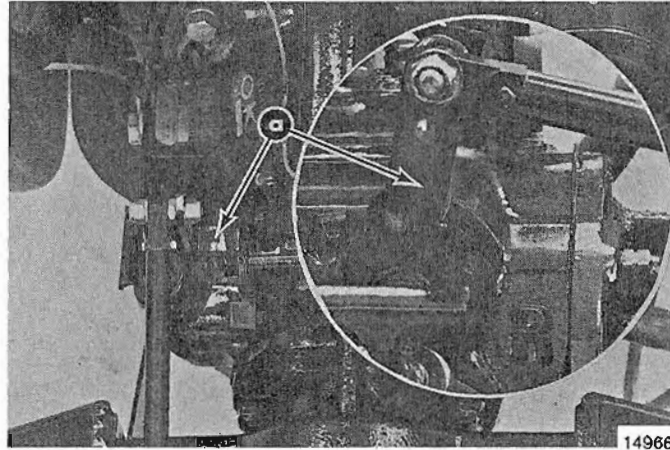
Figure 1. Transmission Shift Lever

a - 71-79B Shift Lever

The shift lever that is used on the Borg-Warner transmission, on the above model engines, is not available from Mercury Marine. If a replacement shift lever is required, order Part No. 71-79B from a Borg-Warner Distributor or dealer.
