STERN DRIVES/INBOARD ENGINES

service bulletin

NUMBER: 82-5

TROUBLESHOOTING THE COOLING SYSTEM ON MERCUISER 4 CYLINDER 224 CID ENGINES (MCM/MIE 470, MCM 485 and MCM 488)

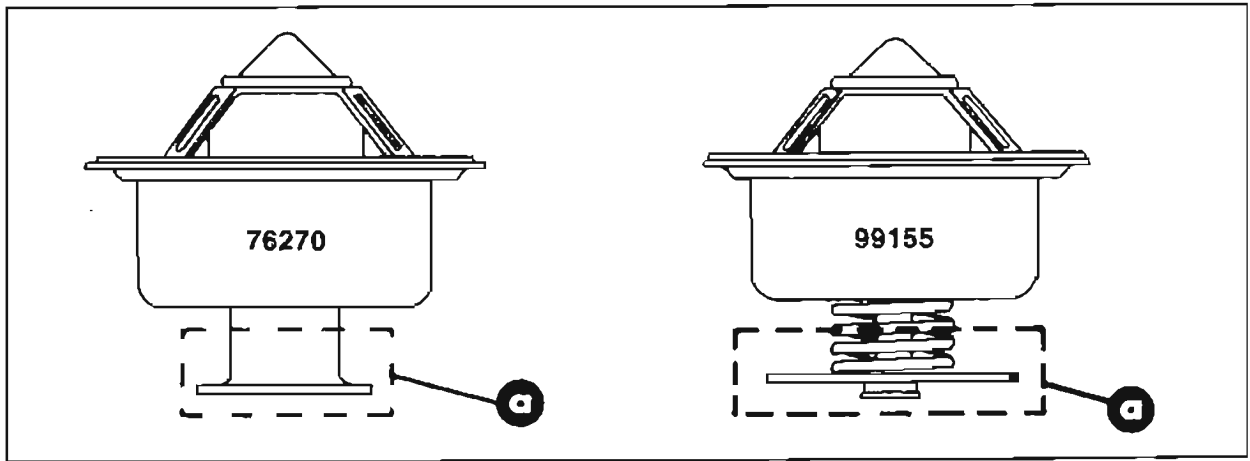
Figure 1. Thermostat

NOTE 8: Automotive thermostats CANNOT BE USED in these engines because they DO NOT direct the coolant flow to the heat exchanger when thermostat is open. (Figure 1)

a - Umbrella Must Be On Thermostat

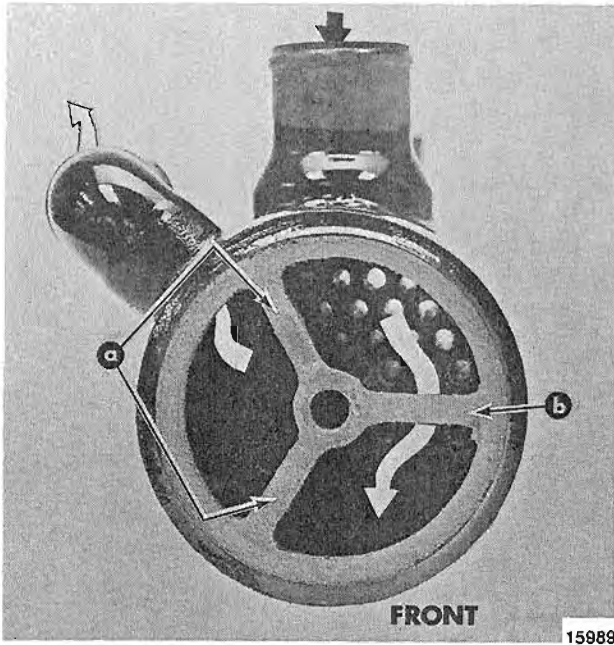
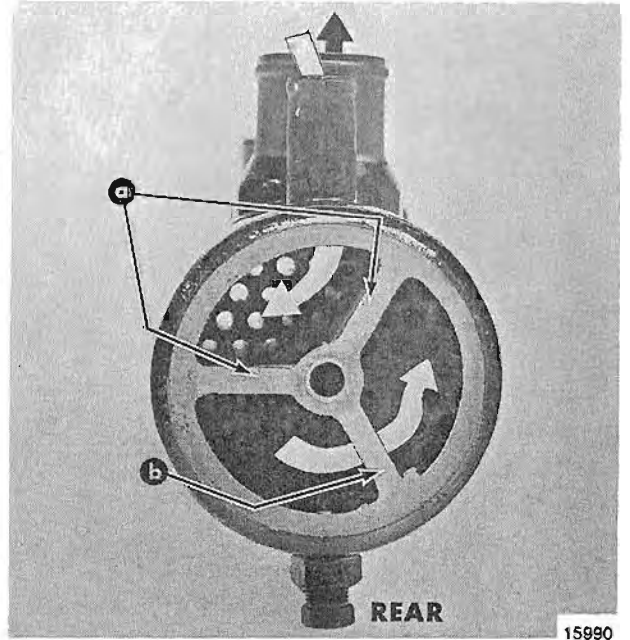
Figure 5. 75959 End Casting Placement [MCM 470 3" (8cm) Dia.]

- a. Freezing the seawater circuit usually forces the end castings out of the shell. These castings can be cleaned, re-inserted properly and soldered in place by a radiator shop. Refer to Figures 5, 6, 7 or 8 for proper placement of end castings.

IMPORTANT: The end castings directs the seawater flow through the heat exchanger in Stern Drive (MCM) Engines. If they aren't installed correctly, the water takes a short cut and two-thirds (or more) of the exchanger is not used.

- **Stern Drive (MCM) Engines with a 3" (8cm) Dia. Heat Exchanger: Seawater passes through exchanger three (3) times before leaving.**
 - **Stern Drive (MCM) Engines with a 4" (10cm) Dia. Heat Exchanger: Seawater passes through exchanger five (5) times before leaving.**
 - **Inboard (MIE) Model Engines: Seawater passes through exchanger once before leaving.**
- b. Internal leaks can be repaired by soldering shut the ends of the leaking tube. This is only a temporary fix because usually another tube will start leaking after a short period of time and this also causes a reduction in cooling capacity. DO NOT close more than 3 tubes.
 - c. Nipples and drains that have been broken off the heat exchanger can be re-attached by brazing. Care must be taken not to melt other joints during repair.

a - Solid Ribs

b - Open Rib

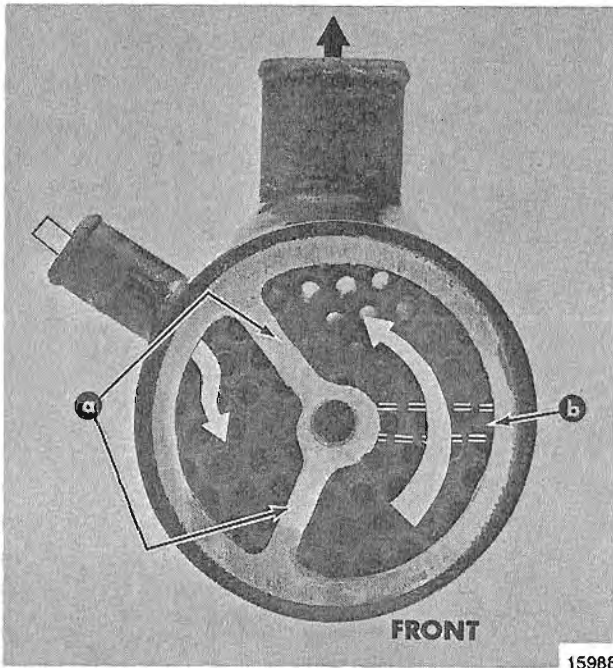
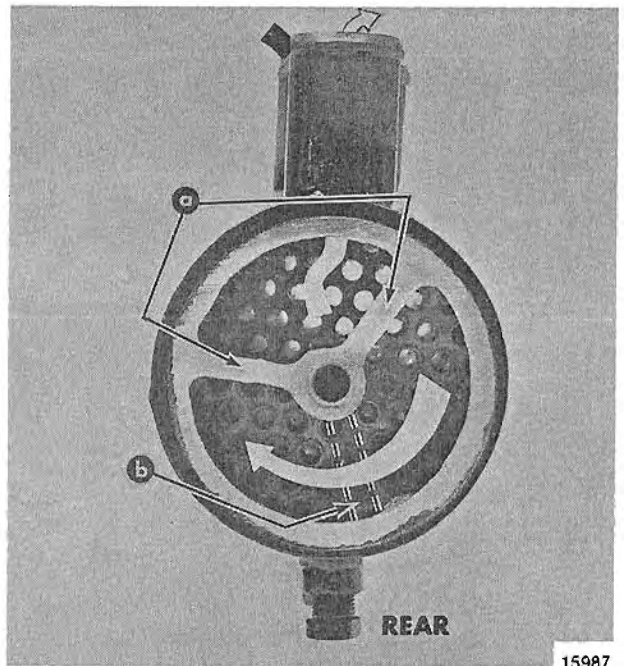
Figure 6. 77319 End Casting Placement [MCM 470/485 3" (8cm) Dia.]

a - Solid Ribs

b - Open Rib (If Exchanger Has 3rd Rib At Each End)

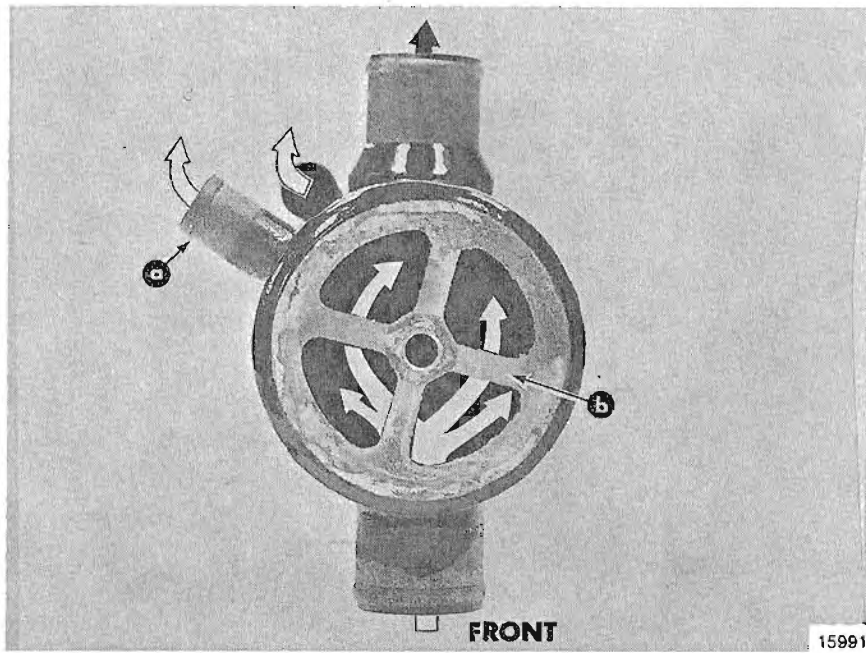
Figure 7. 78165 End Casting Placement [MIE 470 3" (8cm) Dia.]

Seawater Flow
- a - Small Amount of Seawater to Cool Voltage Regulator
- b - All 4 Ribs Are Open

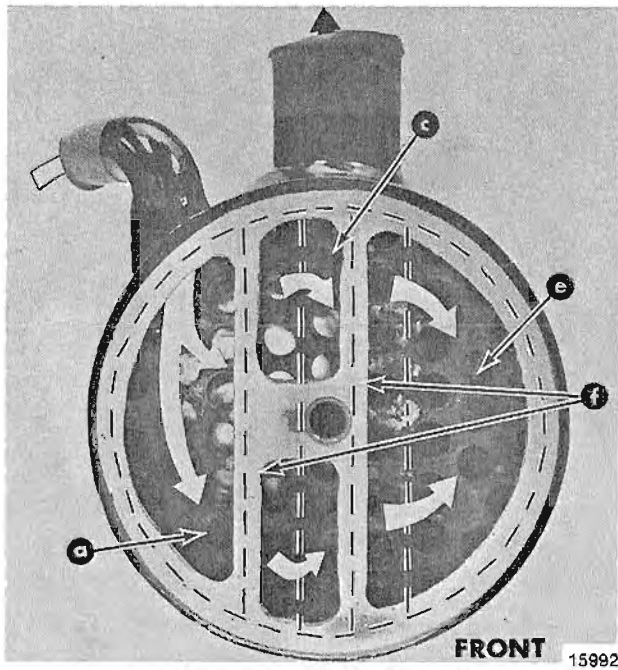
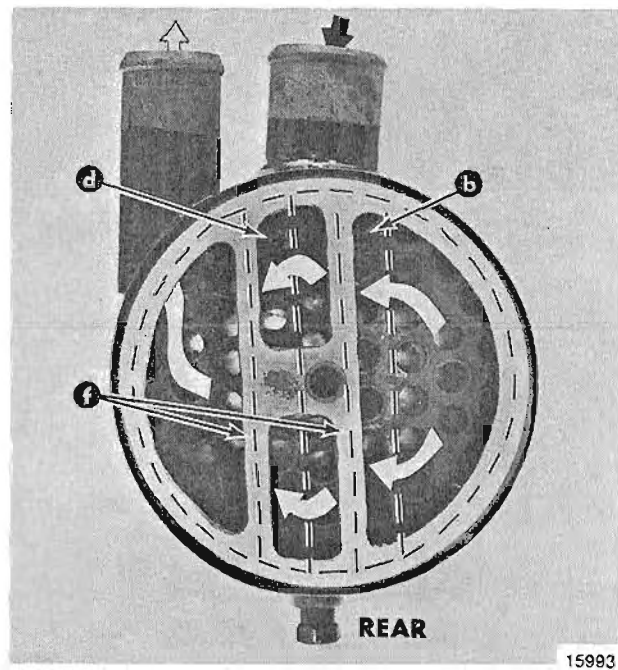
Figure 8. 98643 End Casting Placement [MCM 470/488 4" (10cm) Dia.]

Seawater Flow
- a - 17 Tube Flow To Rear
- b - 8 Tube Flow To Front
- c - 9 Tube Flow To Rear
- d - 8 Tube Flow To Front
- e - 17 Tube Flow To Rear
- f - The Two Ribs On Each End Are Solid
