NUMBER: 82-2

DATE: 5/10/82

Spark Plug Wire Routing on MerCruiser Engines  
Equipped with Rear Mounted Closed Cooling Systems  
- MIE 340 Models

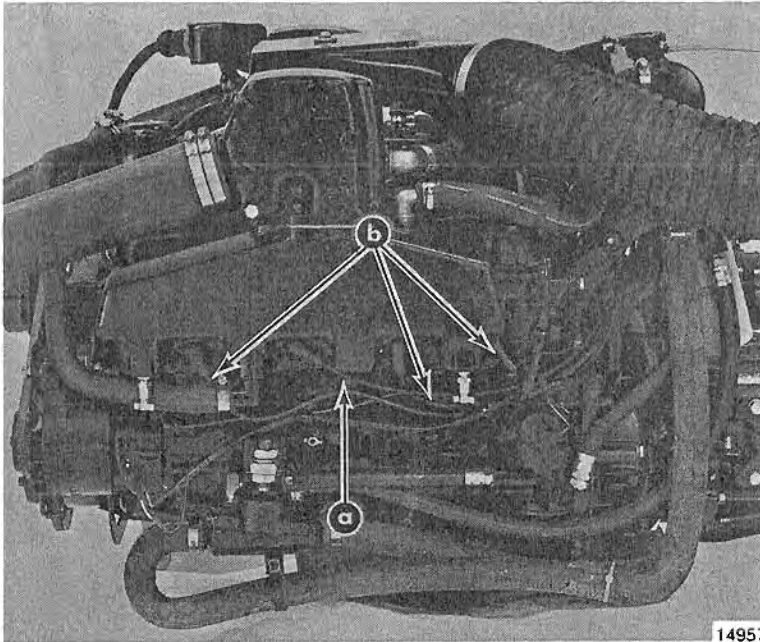
**Figure 1. Spark Plug  
Wire Positioning**

Care must be taken when installing the Rear Mounted Closed Cooling System on the above model MerCruiser engines. If the spark plug wires are not positioned correctly, they can be too close to exhaust manifolds or actually lay against the manifolds causing the wire insulation to burn. (Figure 1)

a - Incorrect  
(Too Close to  
Exhaust Manifold)  
b - Correct

Inspect all MerCruiser MIE 340 engines that are equipped with a Rear Mounted Closed Cooling Systems. If the spark plug wires are not positioned correctly, proceed with the following:

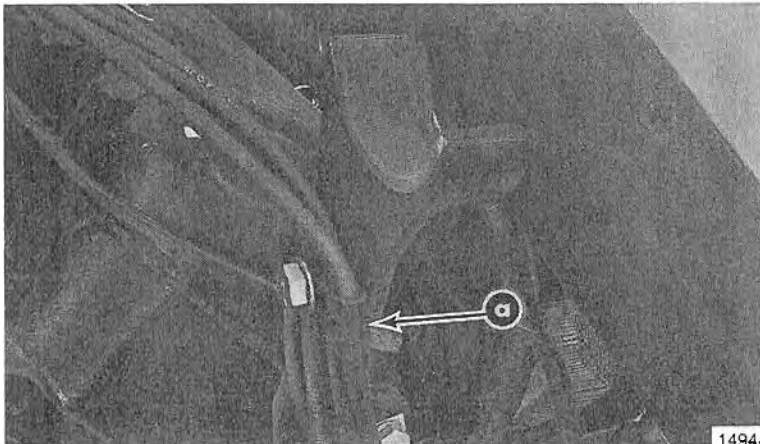
**Figure 2. Starboard Spark  
Plug Retainer**

a - Retainer

1. Make sure wires are routed between oil dipstick tube and cylinder block.
2. Loosen spark plug wire retainers on heat exchanger bracket. (Figures 2 and 3) Pull "slack" in spark plug wires TOWARD spark plugs. Retighten retainers and recheck positioning of wires.

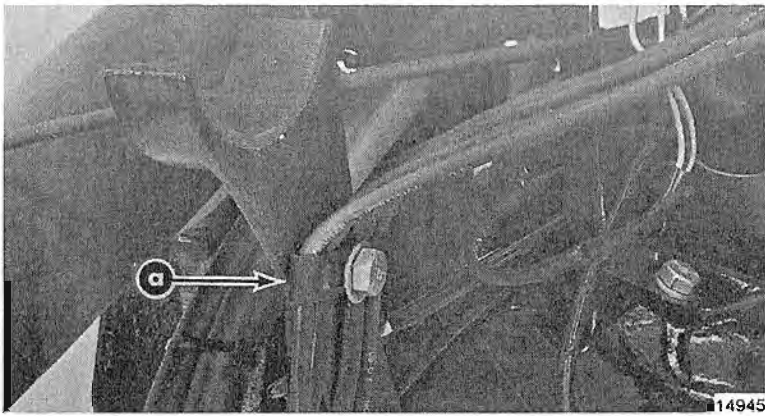
**Figure 3. Port Spark Plug Retainer**

a - Retainer
