- A. Overheating at Idle RPM - MIE 230/260/340 and MCM 330 (B-W) Models
- B. Improved Spark Plug Boot for Thunderbolt IV (HEI) Ignition Systems - MIE 230/260/340 and MCM 898R/228R/260R/330 (B-W) Models
- C. Spark Plug Wire Positioning - MIE 230/260/340 and MCM 898R/228R/260R/330 Models
- D. Quicksilver Insulating Compound

NUMBER: 83-22

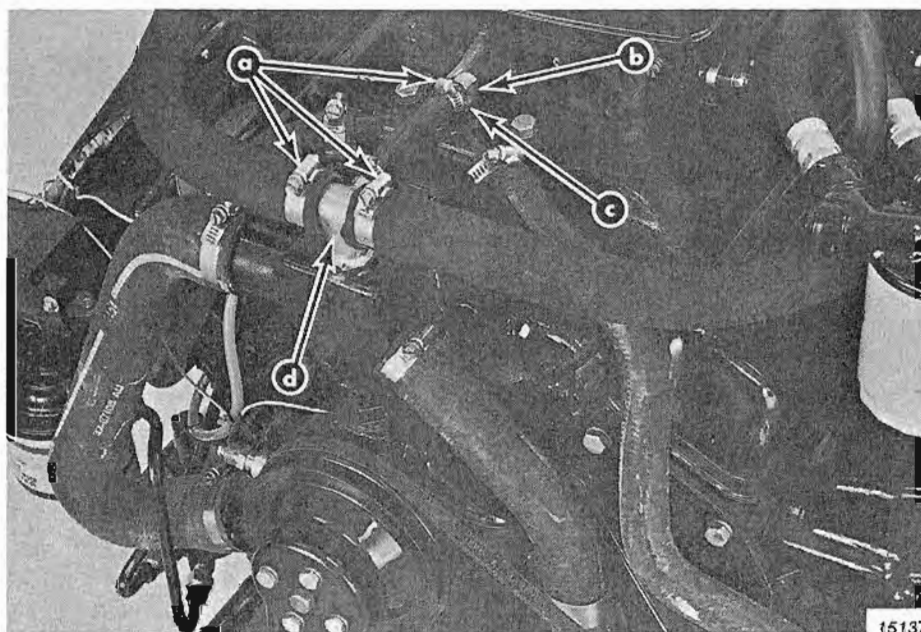
Figure 1. Removing Tee Fitting and Air Bleed Hose

Under certain operating conditions, the above model engines may overheat at idle RPM. Usually by increasing engine RPM, the engine temperature will drop. If this condition exists, order a new tee-fitting (with poppet valves). Install as shown in Figures 1 and 2. Also, install a stainless steel restrictor plate between the exhaust manifold, as shown in Figure 3.

- a - Remove Clamps and Hoses
- b - Remove 90° Elbow
- c - Install 1/8" Pipe Plug
- d - Remove Tee Fitting

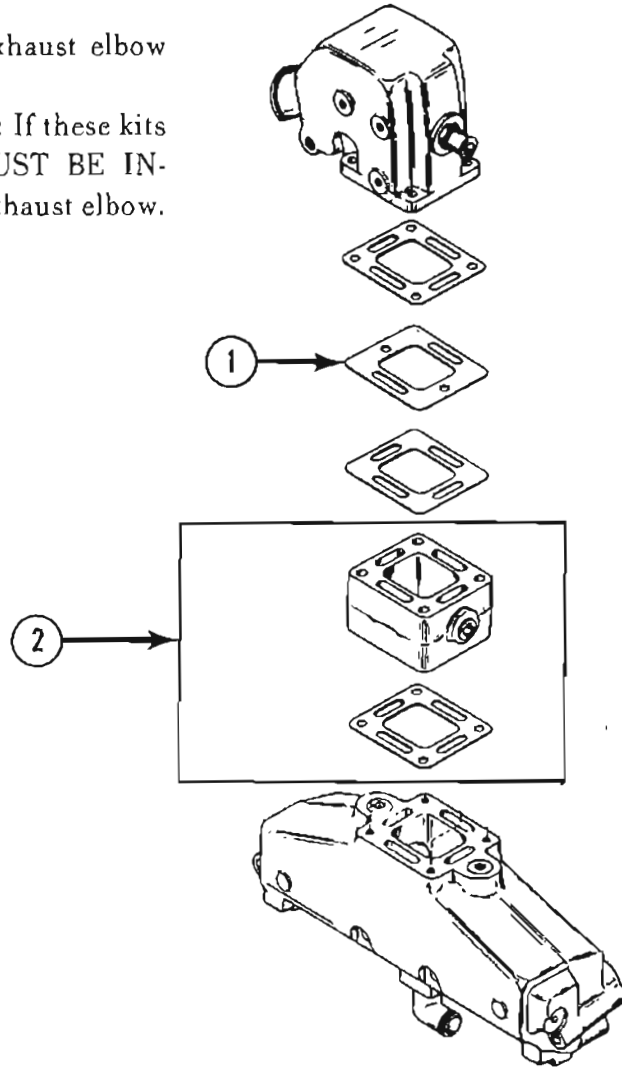
Figure 3. Restrictor Plate Installation

Earlier production and some dealers installed the tee-fitting but not the restrictor plates. It is recommended that when servicing these engines, the restrictor plate be added at that time. The serial number of engines affected are listed below. Engines above these serial numbers have both the tee-fitting and restrictor plates installed in production.

1. Install restrictor plate between exhaust elbow and manifold as shown.
2. 3" or 6" Exhaust Elbow Riser Kits: If these kits are installed, restrictor plate **MUST BE INSTALLED** between the riser and exhaust elbow.

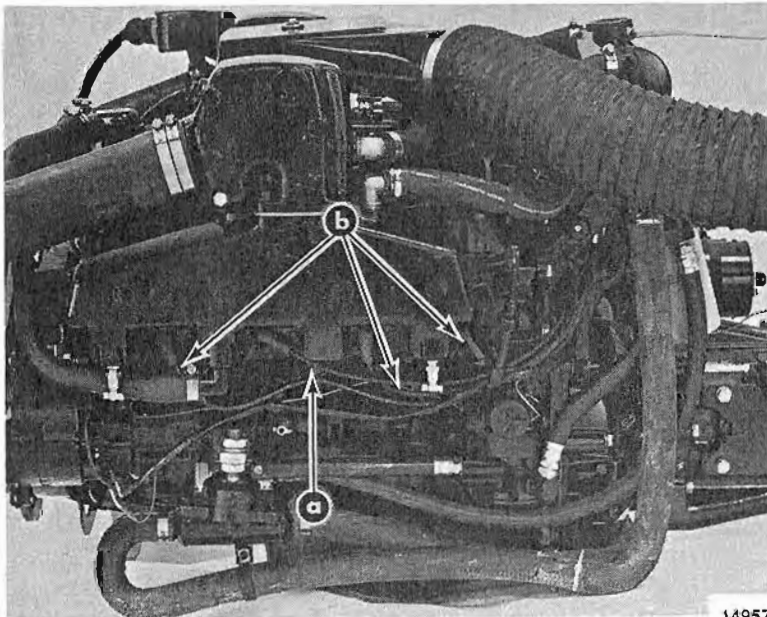
Figure 4. Spark Plug Wire Positioning

Care must be taken when installing spark plug wires or removing the distributor cap. If the spark plug wires are not positioned correctly, they can be too close to the exhaust manifold or actually lay against the manifolds, causing the wire to burn. See Figure 4 for correct positioning.

- a - Incorrect
(Too Close to Exhaust Manifold)
- b - Correct
(Boot Pointed Downward)

After servicing spark plugs, wires or distributor cap, pull slack, in spark plug wires, TOWARD spark plug. Point spark plug boot DOWNWARD and make sure spark plug wire does not come in contact with exhaust manifold(s).
