- A. Drive Shaft Housing Oil Seal Installation Tool for MerCruiser I Models
- B. Water Pump Base Oil Seal Installation Tool for MerCruiser I Models
- C. Special Tap for Installing New Style Shift Cable on MerCruiser I Models

## A. DRIVE SHAFT HOUSING OIL SEAL INSTALLATION TOOL FOR MERCUISER I MODELS

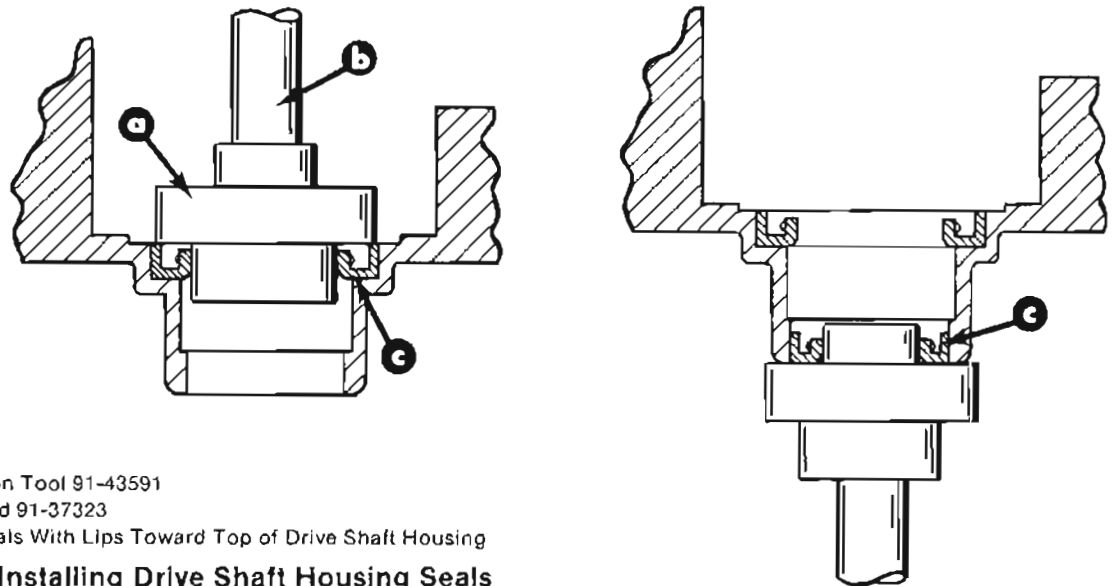
**Figure 1. Installing Drive Shaft Housing Seals**

- a - Installation Tool 91-43591
- b - Driver Rod 91-37323
- c - Install Seals With Lips Toward Top of Drive Shaft Housing

A new Oil Seal Installation Tool, 91-43591, is now available for installing the upper drive shaft oil seals in the drive shaft housing. (Figure 1) The new tool can be used on all MerCruiser I models and replaces Oil Seal Driver, 91-56032, which is no longer available.

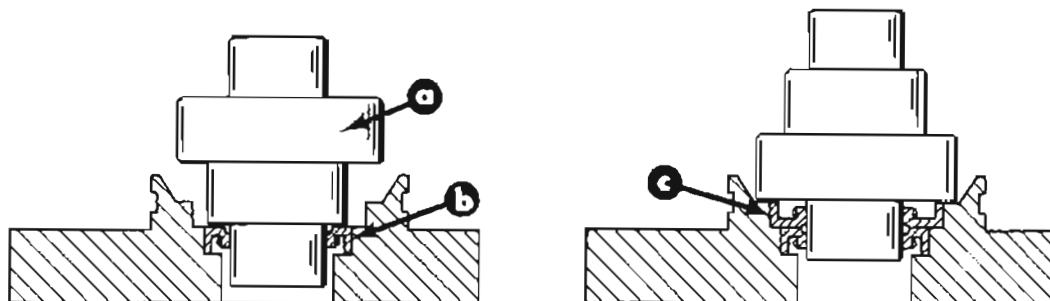
**Figure 2. Installing Oil Seals In Water Pump Base**

- a - Installation Tool 91-44110
- b - Install Upper Seal With Lip Toward Water Pump
- c - Install Lower Seal With Lip Toward Gear Housing

An Oil Seal Installation Tool, 91-44110 is now available for installing oil seals in the water pump base. (Figure 2) This tool will work on all MerCruiser I models and all 75 HP and above Mercury/Mariner models.

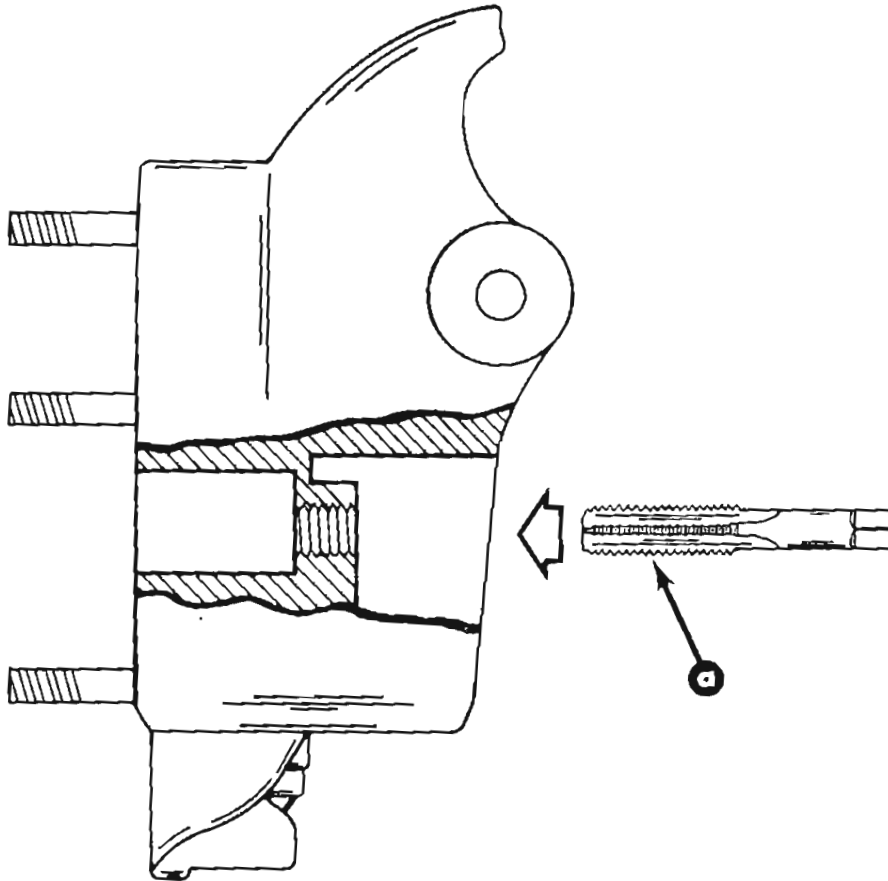
Figure 3. Tapping Threaded Hole In Bell Housing

a - Tap 91-95639

MerCruiser 120R-thru-260R drive unit shift cable, 41951A1 (which attaches to bell housing from aft end) can be used on older MerCruiser I models. To do this, threaded hole in bell housing must be tapped all-the-way thru, using a  $\frac{1}{4}$ -18 NPSF tap. (Figure 3) This special straight thread tap may be difficult to obtain in some areas, therefore, Mercury Marine will now offer it under part number 91-95639. The following important information must be observed when performing tapping operation:

- Tapping must be done from the front (bellows) end of bell housing to prevent cross-threading.
- Never use a tapered thread tap as improper positioning of shift cable may result.
