No. 86-3

MCM 185/205 Wiring Harness Routing S/N A608353 and Below:

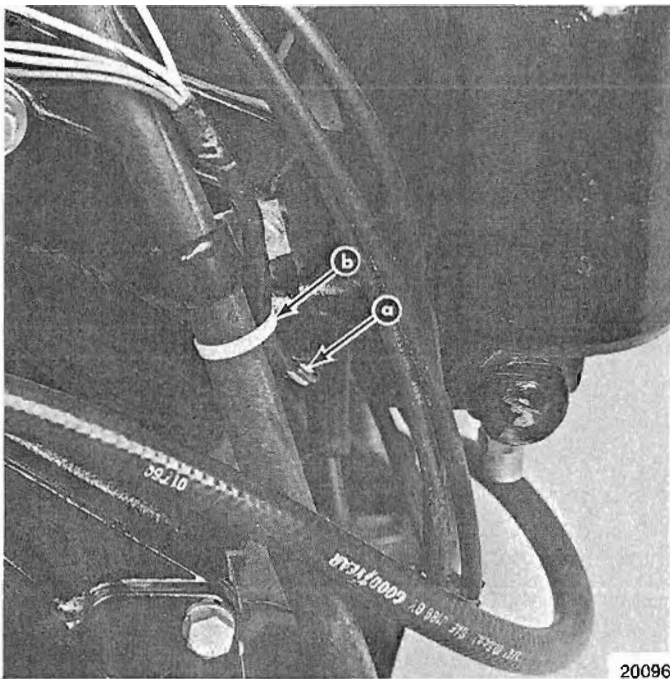
Some reports have been received from the field of the wiring harness chafing and/or melting in the exhaust manifold area on the rear starboard side of the engine as shown, (A) in Figure 1.

IMPORTANT: If the insulation on the wires in this harness becomes chafed or melted so as to ground out a wire, this may cause the ignition system to quit working as if the key switch were turned to the off position. The engine will not restart as long as the ground exists.

1. Remove sta-strap, (B) Figure 1.
2. Loosen coil mounting clamp and relocate coil so primary studs are straight fore and aft as shown in Figure 2. Tighten clamp.

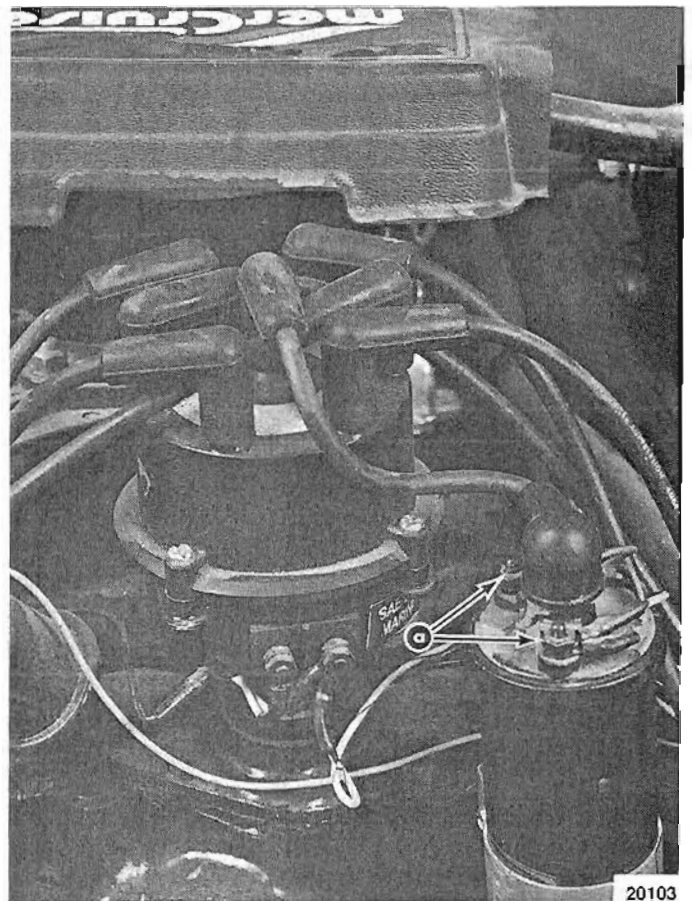
Figure 2.

a - Primary Studs

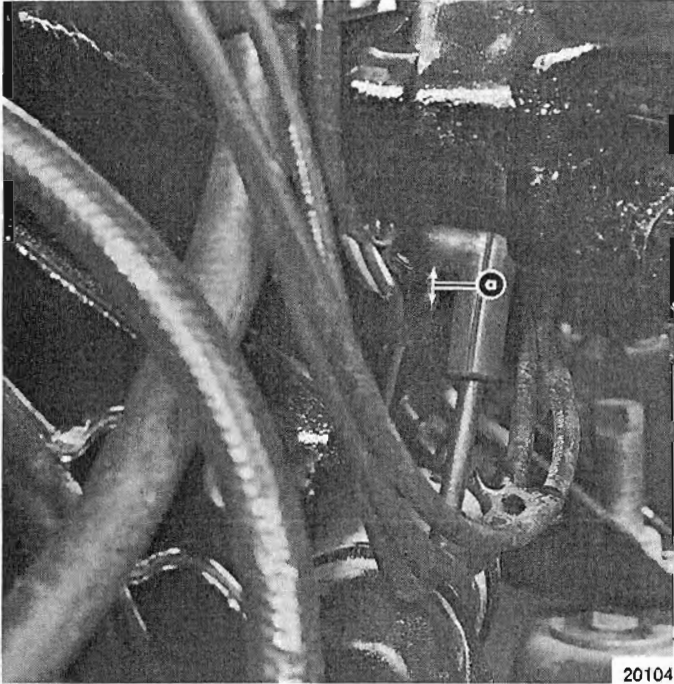
Figure 3.

IMPORTANT: There must be approximately 1" (25mm) clearance between harness and spark plug boot. (Figure 3)

a - 1" (25mm) Clearance

3. Remove spark plug boot and route harness below spark plug (Figure 3). Reinstall spark plug boot.

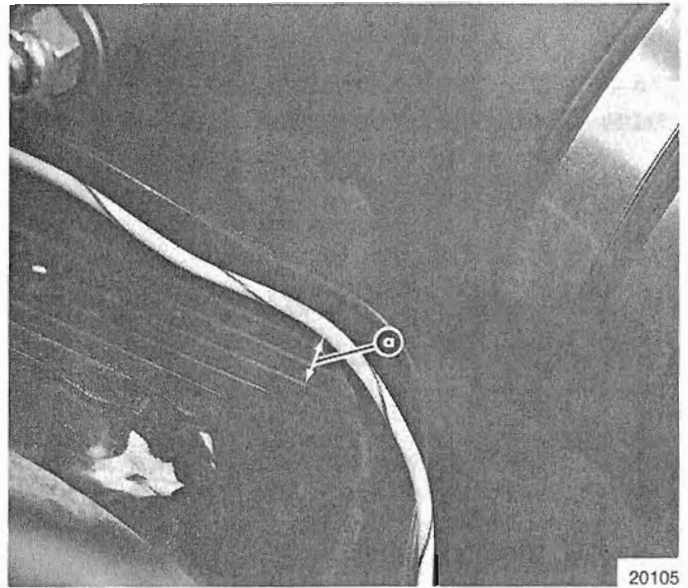
Figure 4.

a - 1" (25mm) Clearance

4. Retape harness if original tape is chafed or melted.
5. Position harness so there is 1" (25mm) clearance between shift cut-out switch wires and rocker cover (Figure 4).
6. Install new sta-strap thru J-clip as shown in Figure 5. Secure harness to J-clip.
