No. 88-18

New Distributor Gear P/N 43-813776-1

454 Magnum (365 HP) Rocker Arms

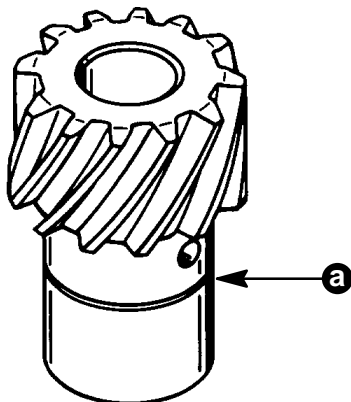
Figure 1.

Distributor gear P/N 43-813776-1 supersedes gear P/N 43-47619-1. The new gear is nitrided and identified by a groove machined around the pilot end, below the roll pin of gear (Figure 1). The reason for the change is that our 4.3L engines with roller lifters have steel camshafts which can cause excessive wear on distributor gears without nitriding. This new gear has been in 4.3L production for several months. The old style gear has been purged from service stock and the new gear is in service stock and may be used in all applications. New 4.3L distributor assemblies P/N 90747A8 in service stock will come with the nitrided gear.

a - Machined Groove

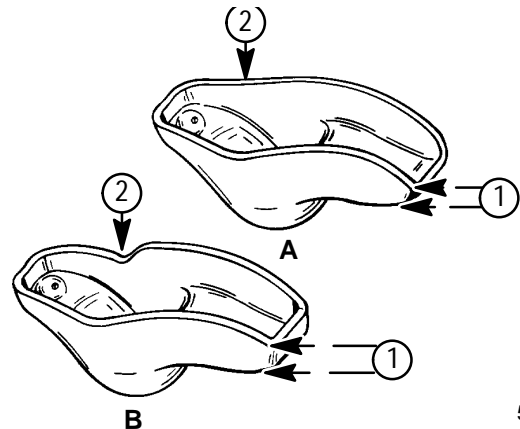
Figure 2.

G.M. has informed MerCruiser that some of our 454 Magnum 365 HP could have rocker arms that are not heat treated correctly. The correct rocker are P/N 19241 is identified by the thickness of edge on rocker arm valve tip (Figure 2), not by a raised "L" on the valve end of the rocker arm as some preliminary information indicated (Figure 3). The correct rocker arms may or may not have any letter on the valve tip.

- A. Correct Rocker Arm
1. Approximate Thickness .220 – .240 (5.6 – 6mm)
 2. No dip in rail
- B. Incorrect Rocker Arm
1. Approximate Thickness .300 – .400 (7.6 – 10mm)
 2. Dip in this rail only
