No. 89-16

## B.M.W. Stern Drive/Inboards Model D636 Diesel Engines (Grey Engines) Overheating

If experiencing an overheating condition with a BMW D636 diesel engine, one of or a combination of the following conditions may be the cause.

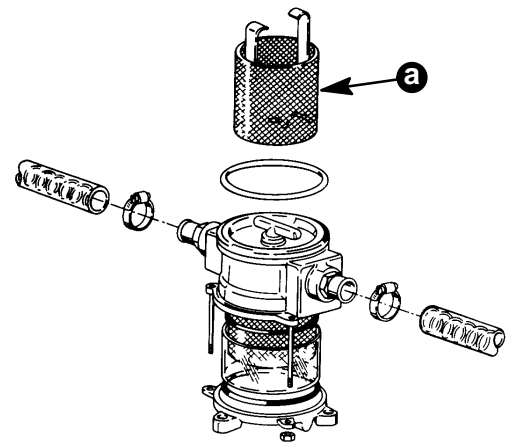
**Figure 1. Raw Water Filter**

a - Check Strainer for Restriction

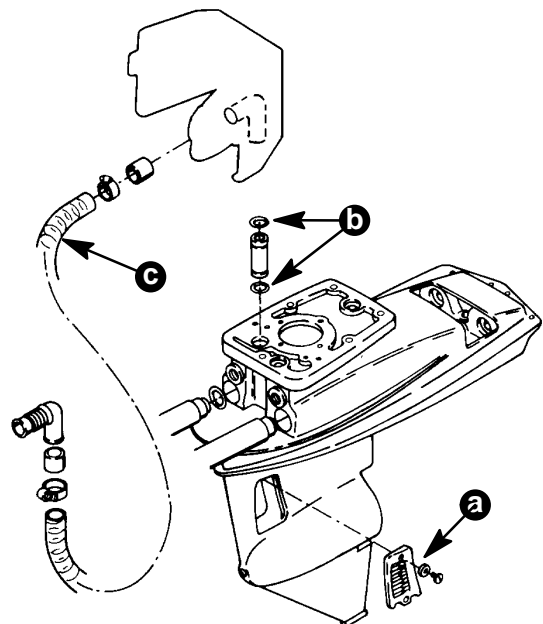
**Figure 2. B.M.W. Stern Drive**

a - Check Water Pick-Up for Restriction  
b - O-Rings Leaking, Not Sealing  
c - Inlet Hose Tore or Kinked

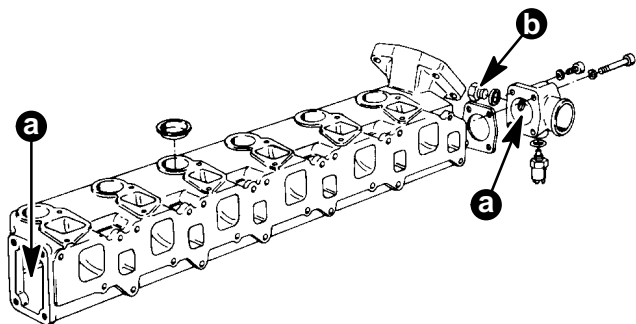
**Figure 3. Intake/Exhaust Manifold**

a - Water Passages Restricted

b - Remove Plug for Exhaust Pressure Check

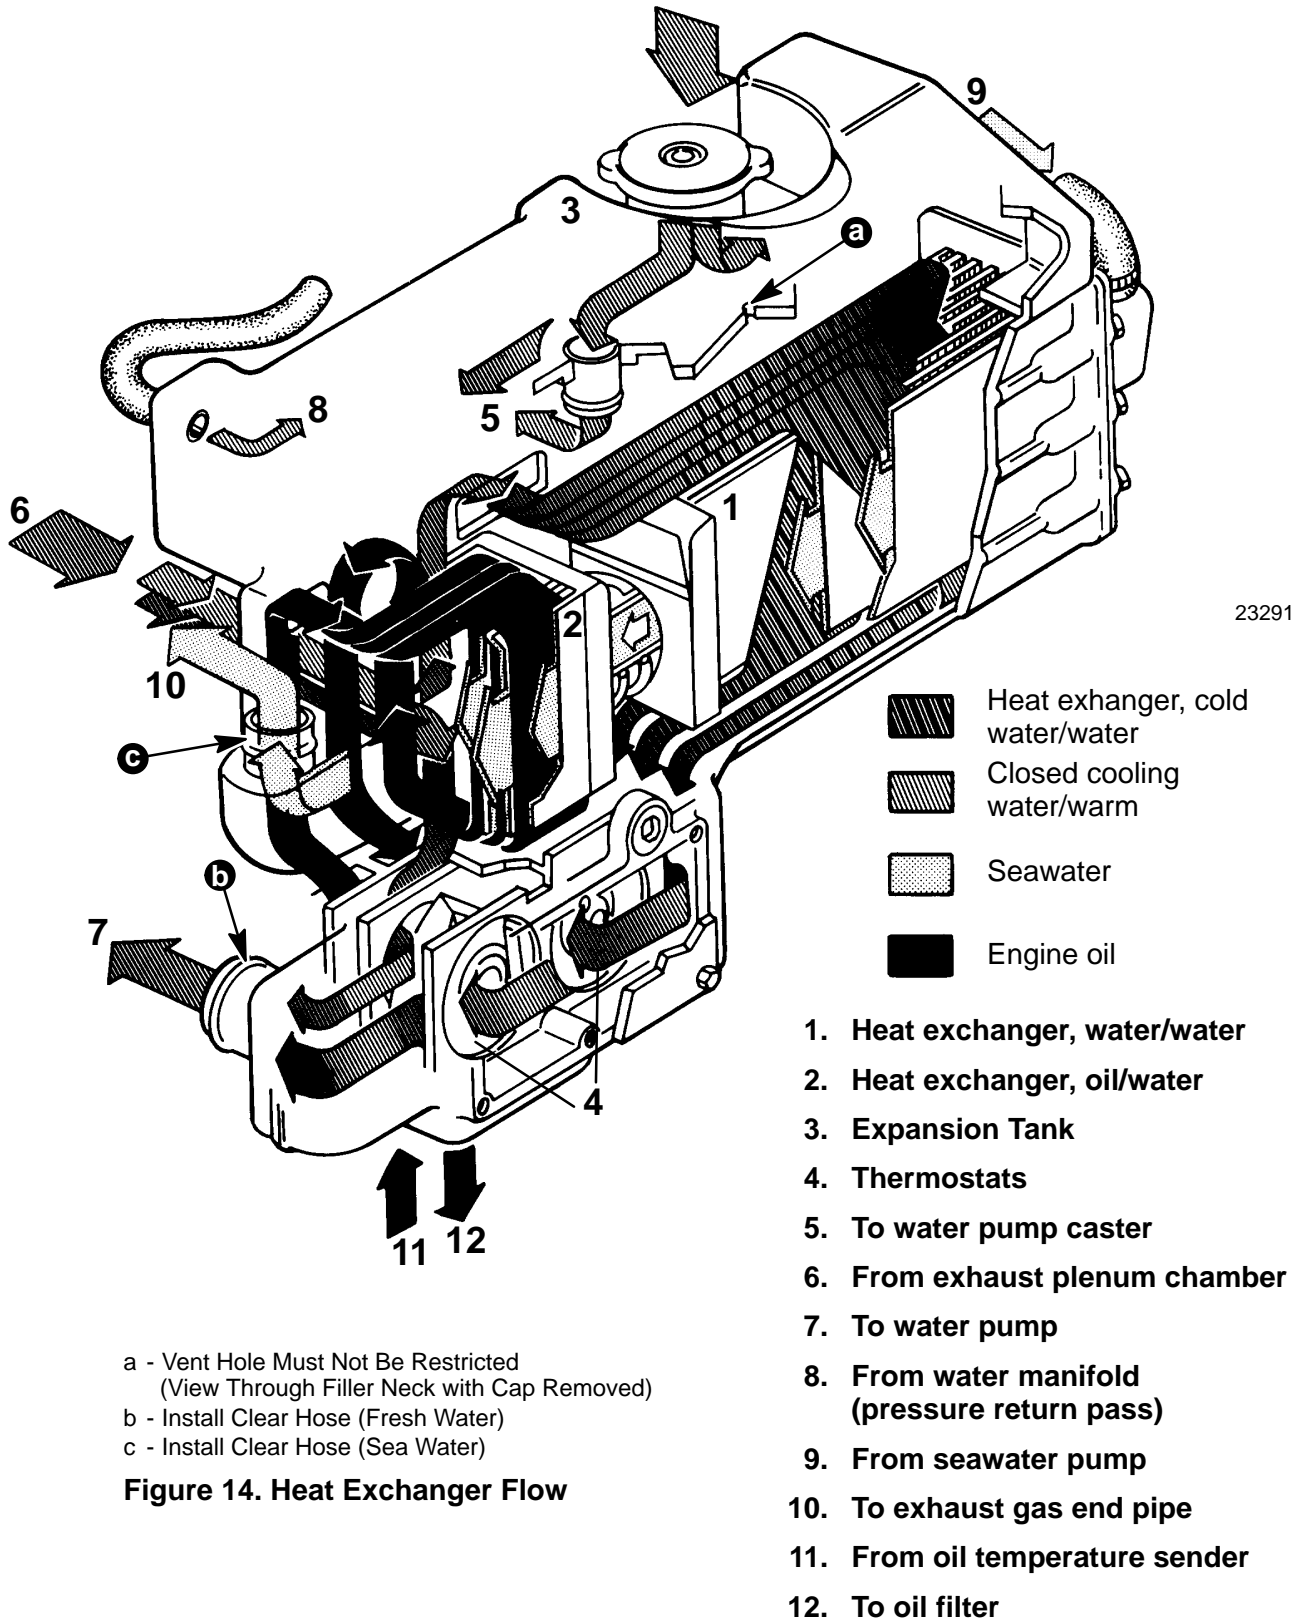
- b. Replace hose between heat exchanger and engine circulating pump with clear plastic hose. (Figure 4, "b") Watch for gas bubbles.
9. Check the following if excessive pressure or gas bubbles are found.
    - a. Head gasket leakage by making a compression test.
    - b. Exhaust gases existing in the closed cooling system by using a combustion leak tester.

Replace hose between heat exchanger and exhaust elbow with clear hose. (Figure 4, "c") Watch for air bubbles. If air bubbles are present the complete sea water system must be checked for leaks.

11. Check if vent hole in heat exchanger directly under filler cap is open. (Figure 4, "a")

**IMPORTANT: Hole diameter must not be enlarged from original size of 3/32" (2.5mm).**

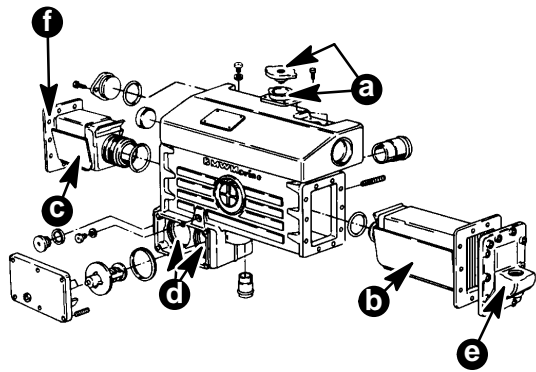
**Figure 5. Heat Exchanger Tank**

12. Check thermostats for proper opening degrees.  
170°F – 178°F (77°C – 81°C). (Figure 5, “d”)

- a - Replace with New Double Lip Seal Cap and Neck
- b - Coolant Exchanger
- c - Oil Exchanger
- d - Dual Thermostats
- e - Raw Water Outlet
- f - Raw Water Inlet (Not Shown)

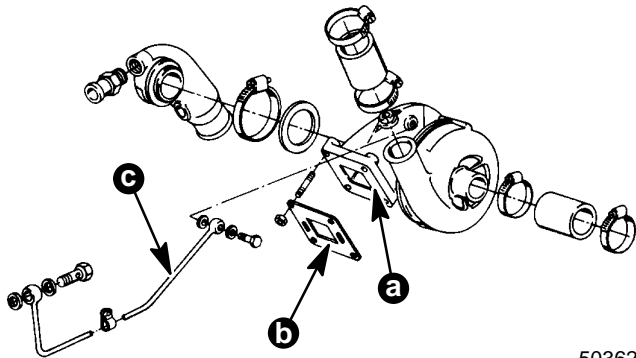
**Figure 6. Turbo Charger**

13. Check vent line from turbocharger to expansion tank (Figure 6, “c”) and from water manifold to expansion tank (Figure 7, “b”) are open.

- a - Water Passages Restricted
- b - Gasket Leaking
- c - Vent Line Restricted

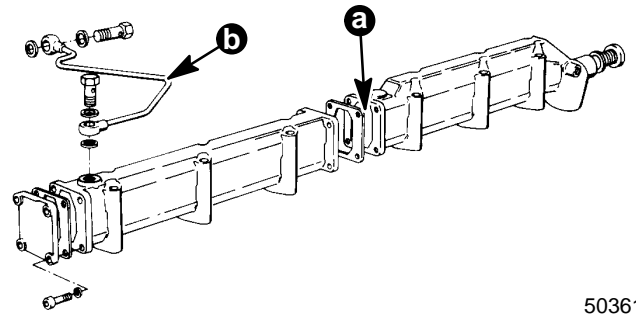
**Figure 7. Water Manifold to Cylinder Heads**

- a - Water Passage Restricted
- b - Vent Line Plugged
