No. 89-21

MerCarb Flooding and/or Rough Idling MCM 2.5L, 3.0L and 3.7L Engines

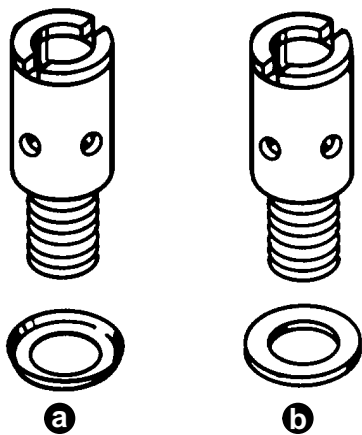
Figure 1.

Inspect gasket under seat fitting. If gasket is "cup shaped" replace it. The gasket "cups" because the O.D. of some gaskets were too large. (Figure 1) Order new needle/seat.

a - Cupped Gasket (Oversized O.D.)

b - Flat Gasket (Correct O.D.)

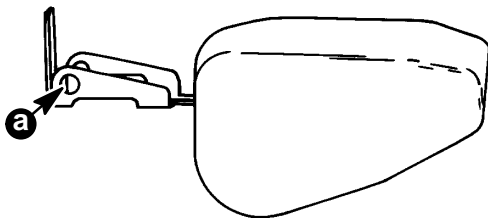
Figure 2.

Inspect float pivot pin holes for excessive wear. (Figure 2)

a - Float Pin Holes

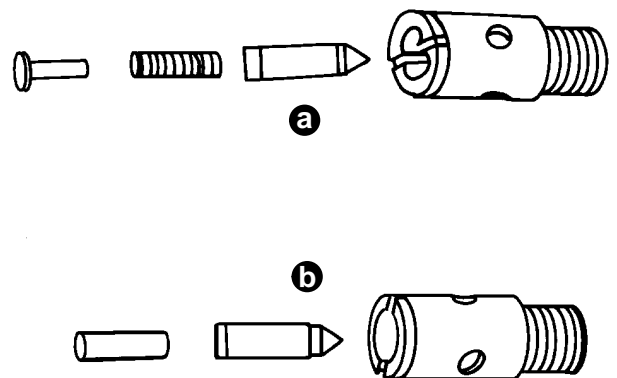
Figure 3.

a - Spring Loaded Needle & Seat P/N 3302-9029

b - Solid Two Piece Needle & Seat P/N 3302-9407

If all the preceding specifications and components check out okay and there still is a flooding and/or rough idle condition change to the spring loaded needle and seat P/N 3302-9029 (Figure 3). This needle and seat will help control flooding in MerCarbs that may be affected by the inherent vibration characteristics of a 4 cylinder engine.

Float level specification for spring loaded needle and seat is 9/16 in. (14mm). Raise float and allow it to fall on spring. DO NOT force float downward by hand.
