## Anti-Fouling Paint on Aluminum Drives

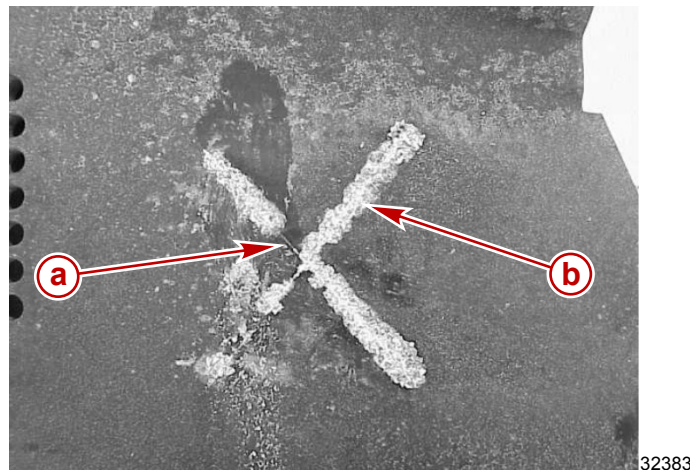
Marine growth is a common problem in saltwater environments. To prevent marine growth, many boaters use anti-fouling paint. Most modern anti-fouling paints contain copper. Copper retards marine growth but causes aluminum to corrode when both are immersed in salt water.

The following photograph illustrates this corrosion. It shows an aluminum drive coated with anti-fouling paint that contains copper. To simulate damage, we intentionally scribed the drive with an X to expose bare aluminum. The drive was then immersed in coastal seawater for three weeks.

- a** - Original scribe mark
- b** - Mark after three weeks of corrosion

This test illustrates how quickly corrosion can spread on a damaged drive that is coated with copper-based anti-fouling paint if it is not properly repaired. Mercury Marine is currently testing both commercially available and experimental anti-fouling paints to provide clear product recommendations for our dealers and customers. We will provide a definitive recommendation after we complete this evaluation.

- Use a paint with the lowest possible copper content that will adequately protect your boat from fouling in the waters where you do the majority of your boating.
- Before applying anti-fouling paint to the drive, properly repair the damaged area of the factory-painted surface to ensure that no bare aluminum is exposed. The original paint layer provides an important barrier that prevents copper ions from reaching the bare aluminum.
- Repair any damage to the factory-applied paint and ensure that no aluminum is exposed before applying anti-fouling paint. The original paint layer provides an important barrier that prevents copper ions from reaching the aluminum itself.
- Do not paint the anodes. These pieces of aluminum or zinc are meant to corrode as a method of protecting the aluminum drive. Replace an anode when 50% of its mass has eroded.

**IMPORTANT: Do not use magnesium anodes in salt water. Magnesium, like copper, can damage aluminum in seawater.**

1. Remove the anti-fouling paint in the affected area.
2. Apply the repair paint and let it cure.
3. Apply the anti-fouling paint.
