Bulletin No. 2001-06

## ▲ Required 496 MAG / 496 MAG HO / 8.1S / 8.1S HO Push Rod Replacement

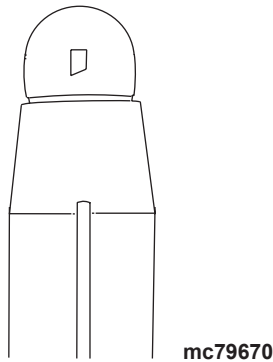
1. Remove rocker arm covers.
2. Examine pushrods.
  - Tapered Design - If tapered reinstall the rocker cover (see installation step 4)

- Straight Design - If straight, replace all pushrods

All straight intake and exhaust valve push rods must be replaced with new push rods that have a machined taper on each end.

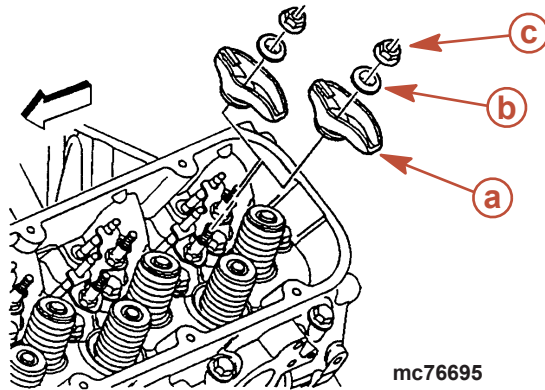
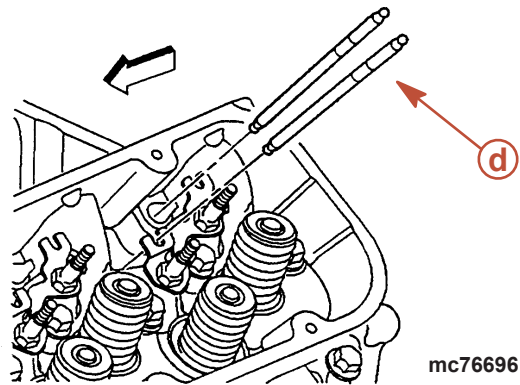
4. Inspect all contact surfaces for wear. Replace all damaged parts.
