Bulletin No. 2003-06

V6 and V8 GMEFI with No Start, Engine Miss-Fire or Engine Shut-off Conditions

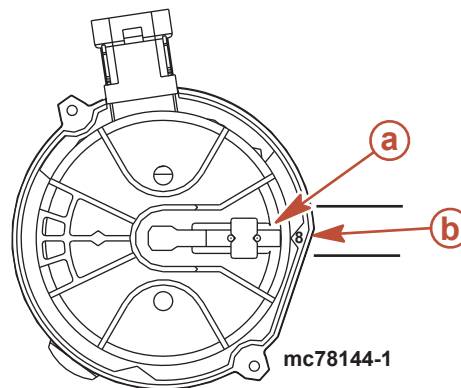
2. V8 engines only: If the performance of 1a and 1b (above) does not resolve the problem, bring the engine to TDC (firing). Remove the HVS distributor cap and verify that the rotor is pointing at the correct timing mark, 8, on the HVS housing between the 2 lines shown below. If this is correct, reinstall the HVS cap. Mark a reference line on the HVS distributor and intake manifold (so you know where the distributor was located after you move it in the following step). Loosen the distributor's clamping screw and rotate the distributor 1-2 degrees clockwise (viewed from top), then retighten the distributor's clamping screw. The engine should now run well. If it does not, then you can return it back to the original line that you marked before.

a - Rotor tang

b - "8" on housing

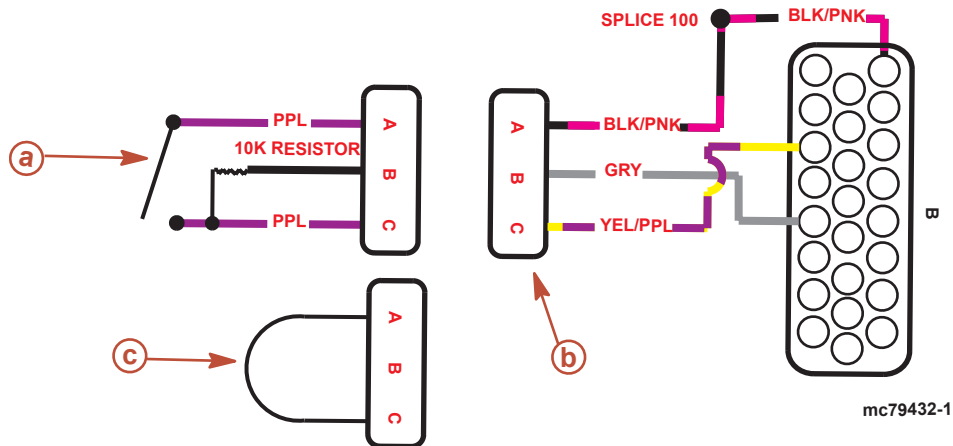
- MCM V6 and V8 MPI Alpha engines only: If you have an Alpha engine with an engine miss-fire or if the engine shuts off above 1200 rpm, the problem may be caused by the shift interrupt switch. To determine if the interrupt switch is the cause, disconnect the switch from the engine wiring harness. Use a small jumper wire to go between the A and C terminals in the engine harness connector.

- a** - Shift interrupt switch
- b** - Engine harness connection
- c** - Jumper wire between A and C terminals

If the jumper wire corrects the engine running condition, a new ECM with the latest calibration should be installed. Alpha engines built above the S/N below have the new ECM 555. If an ECM is needed, order the correct one listed below.
