OFFICIAL RECALL NOTIFICATION U.S. FEDERAL BOAT SAFETY ACT

## Plug Missing From Turn Key Start Carburetor Retrofit Kits

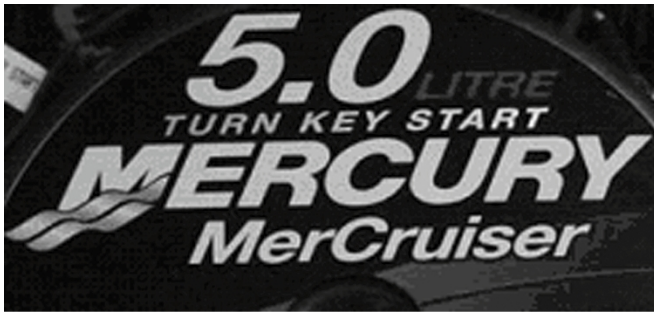
13267

Turn Key Start carburetors can be identified by the words "TURN KEY START" under the displacement designation on the flame arrestor decal and the electrical module mounted on the side of the carburetor.

Flame arrestor decal

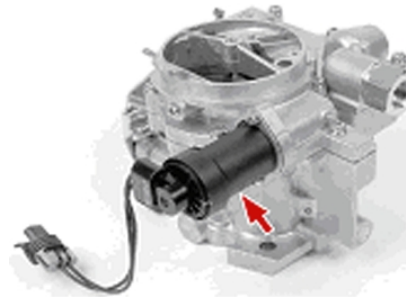
13268

(TKS) Electrical module

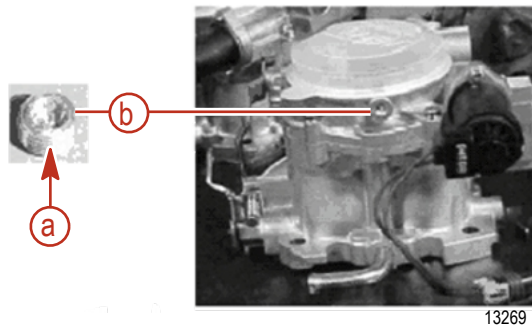
13269

Carburetors supplied with the above listed kits and installed on affected models may not have been equipped with pipe plug p/n 22-56800.

a - Pipe plug

b - Pipe plug installation location

Install the missing pipe plug in the carburetor as shown. Tighten plug to torque of 30 lb-in. It is very important that all paint is removed from the threads of the carburetor before installation of the plug. If not, the plug does not install correctly.
