Revision to Recall Notification 96-13: Commander 3000 Remote Control Product Update

NOTICE
This Bulletin supersedes MerCruiser Service Bulletin 96-13.

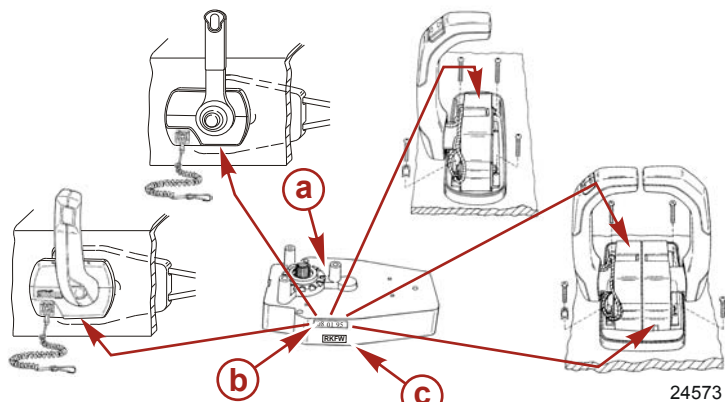
2. **Rework Identification:** Commander 3000 remote controls built between June 1, 1994, and September 1, 1995, that have been reworked at the factory have a decal with the letters "RKFV" on the control. The affected gear has been replaced on these controls and the control is approved for use.
3. **Determine whether you have a Commander 3000 control that is included in this recall.** View the decals on the control, if visually accessible, in the location shown below. Use a flashlight and mirror to help read the decals.

IMPORTANT: If your remote control was built between June 1, 1994, and September 1, 1995, and does not have a "RKFV" decal, you are affected by this recall and must have the control mechanism replaced.

a - Control mechanism
b - Build date decal

c - RKFV decal

NOTE: The date may appear on the control in different forms: 08/01/95 (month/day/year) August 1, 1996. The month may also be written out in alpha characters as in the following: Aug/1/95 or 1/Aug/95. Decals may appear in other locations.

The mechanism of Commander 3000 remote controls built between June 1, 1994, and September 1, 1995, that do not have the "RKFW" decal, and those found with no build date must be replaced with a Gen II Remote Control, and Gen II Cables as described in the tables below. The Gen II Remote Control must be used with Gen II Cables for this replacement as the Gen I Commander 3000 Remote Controls are no longer available (NLA).
